Service Information Sheet No. 11

CLUTCH ADJUSTMENT

The M.G. Car Company Ltd.

K, L, P, N, KN & PB Models

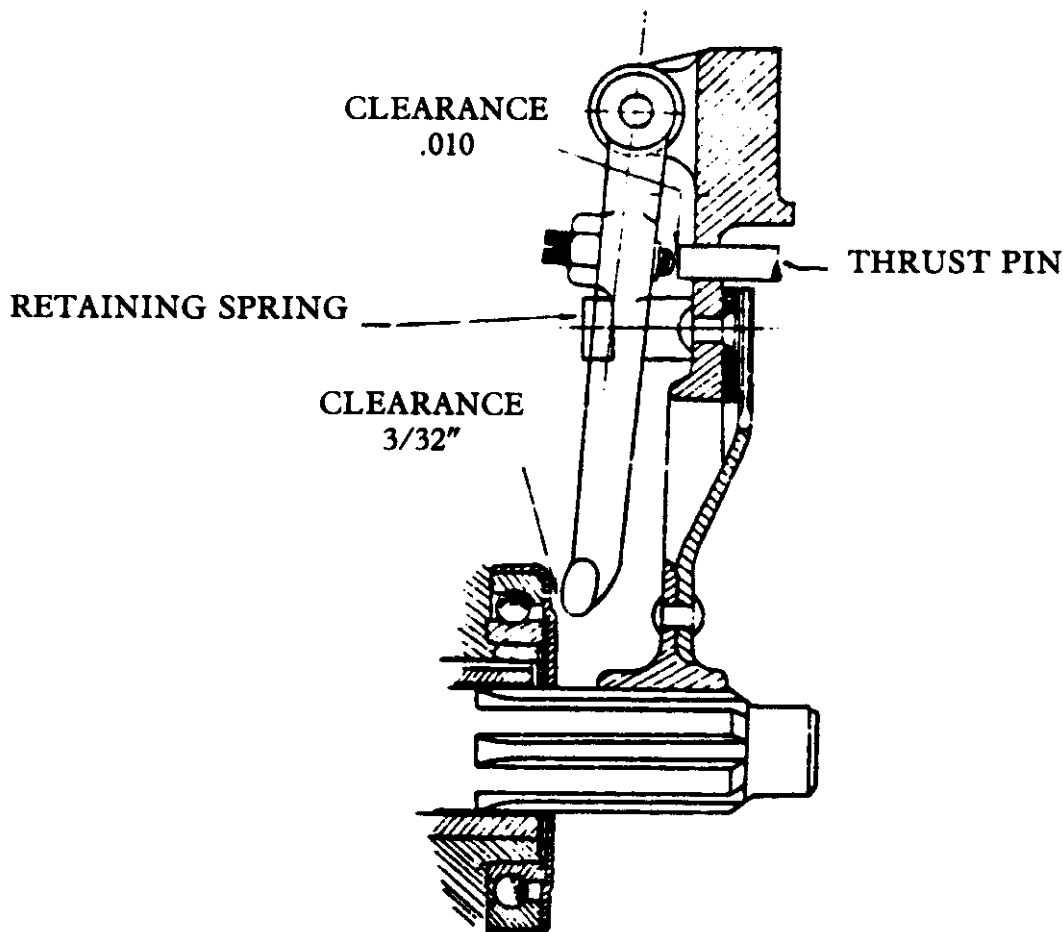
It has been thought advisable to issue information regarding clutch adjustment as cases have come to our notice where incorrect adjustment has caused excessive wear to the clutch fingers. The first adjustment is between the clutch fingers and the clutch thrust race. The clearance should be measured by a gauge $3/32$ in. thick (see drawing), care being taken to get the same clearance for each finger.

The second adjustment, which is equally important, concerns the amount of movement the clutch fingers have between the retaining springs and clutch operating pins. The duty of the retaining springs is to prevent the fingers fouling the thrust race. These springs, therefore, should be set carefully to allow a $.010$ in. gauge to be inserted between the clutch adjusting screw and the clutch thrust pin, as indicated on the drawing.

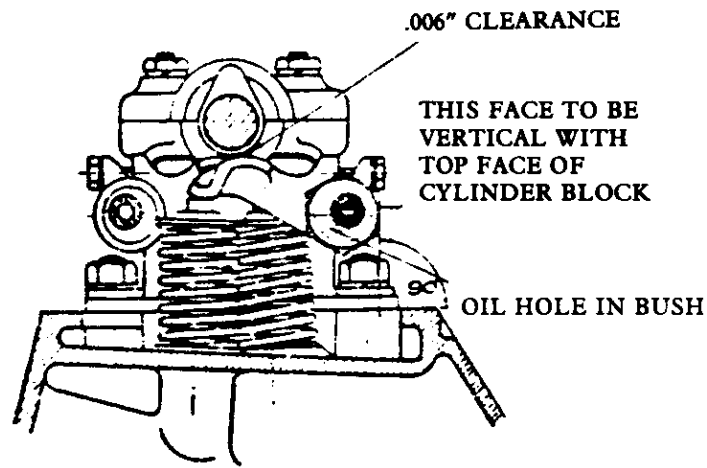
FIG. 1
SHOWING POSITION OF
ECCENTRIC BUSHES FOR
J. MODELS

It is possible for a person not acquainted with the engine to set the rockers in various wrong positions which will cause considerable variation of timing on the corresponding valve.

1. Set the rocker eccentric bush in the position shown in Fig. 1 for the J. Type and that as shown in Fig. 2 for the K., L., PA., N., KN. and PB. Type models.

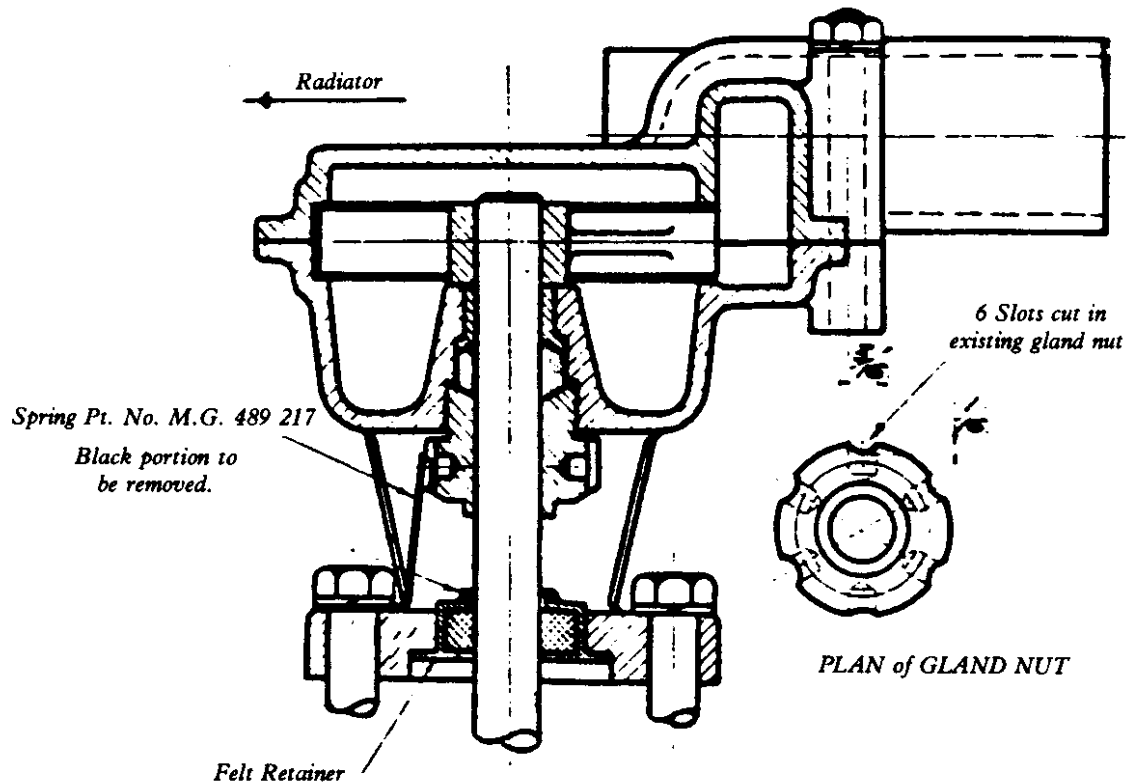
A new gland nut retaining spring has been designed to supercede the original type coil spring.

This spring is more positive in action and eliminates the possibility of water (which may leak past the gland) finding its way into the sump past the spindle sealing felt, owing to it being trapped by the coil spring.

The existing gland nut is slotted to receive the new spring.

The coil spring spigot is removed from the spindle felt retainer.

The new retaining spring is secured by means of the front set screw which secures the pump to the front bearing housing.

The water drain hole is increased from $\frac{1}{8}$ in. diameter to $\frac{5}{32}$ in. diam.
