*Service Information*

*Published by*  
**The M.G. Car Company Ltd.**  
*Abingdon-on-Thames*

Date of Issue: March, 1936

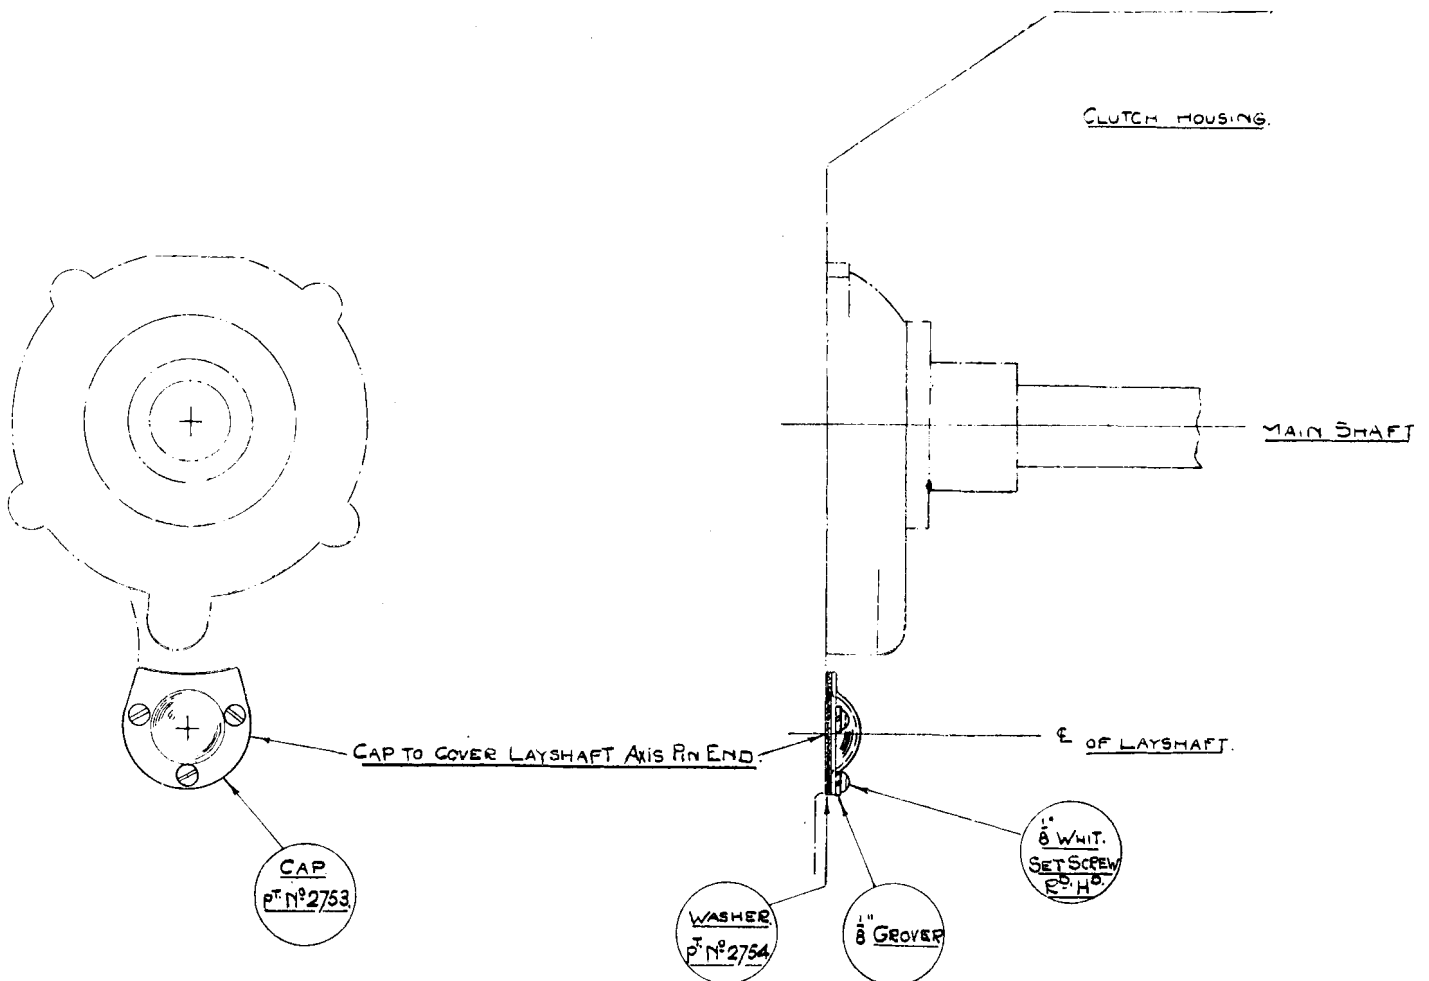
**GEARBOX OIL LEAKAGE FROM LAYSHAFT**

On all these models a gearbox is used having a double-helical constant mesh and third speed, also sliding gears for the other ratios. It has been found in service that an escape of oil into the clutch housing may occur through the front layshaft axis pin, which is pressed into the case.

This trouble is not very prevalent, but when it is found a small cover fitted with a washer and three screws can be fitted to prevent a recurrence.

The drawing herewith (Service Blue Print No. 147) gives particulars of the cover, screws and washer, and also shows its location on the gearbox.

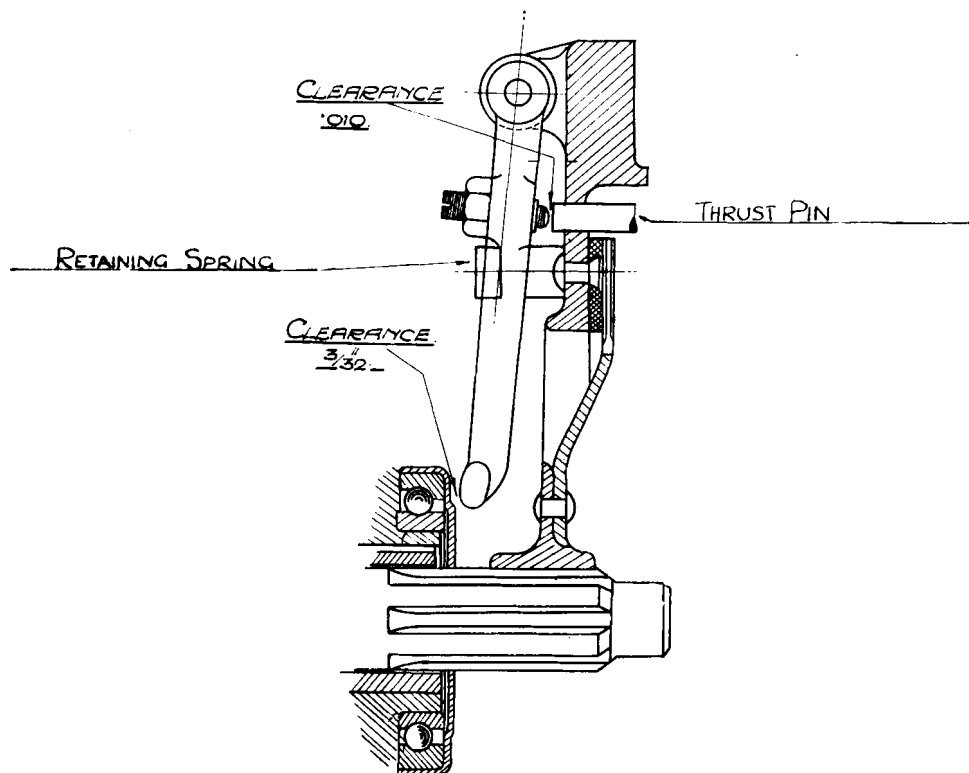
It has been thought advisable to issue information regarding clutch adjustment as cases have come to our notice where incorrect adjustment has caused excessive wear to the clutch fingers. The first adjustment is between the clutch fingers and the clutch thrust race. The clearance should be measured by a gauge  $\frac{3}{32}$  in. thick (see drawing), care being taken to get the same clearance for each finger.

The second adjustment, which is equally important, concerns the amount of movement the clutch fingers have between the retaining springs and clutch operating pins. The duty of the retaining springs is to prevent the fingers fouling the thrust race. These springs, therefore, should be set carefully to allow a .010 in. gauge to be inserted between the clutch adjusting screw and the clutch thrust pin, as indicated on the drawing.

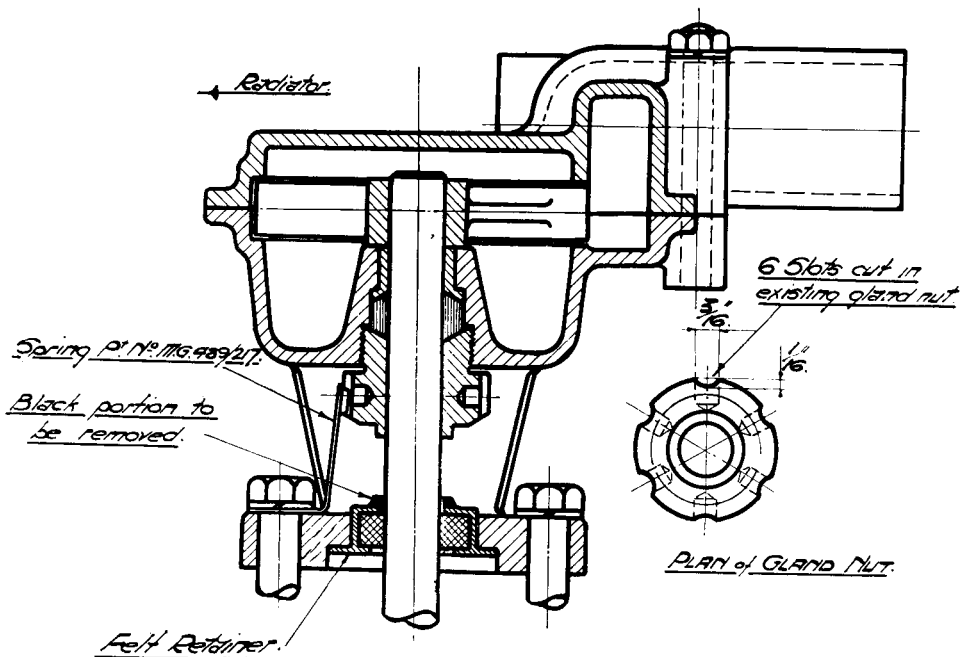
This spring is more positive in action and eliminates the possibility of water (which may leak past the gland) finding its way into the sump past the spindle sealing felt, owing to it being trapped by the coil spring.

The water drain hole is increased from  $\frac{1}{8}$  in. diam. to  $\frac{5}{32}$  in. diam.

Supplies of the new spring, Part No. M.G.489/217, can be obtained on application being made to our Service Stores Department. Price 9d. each (retail).

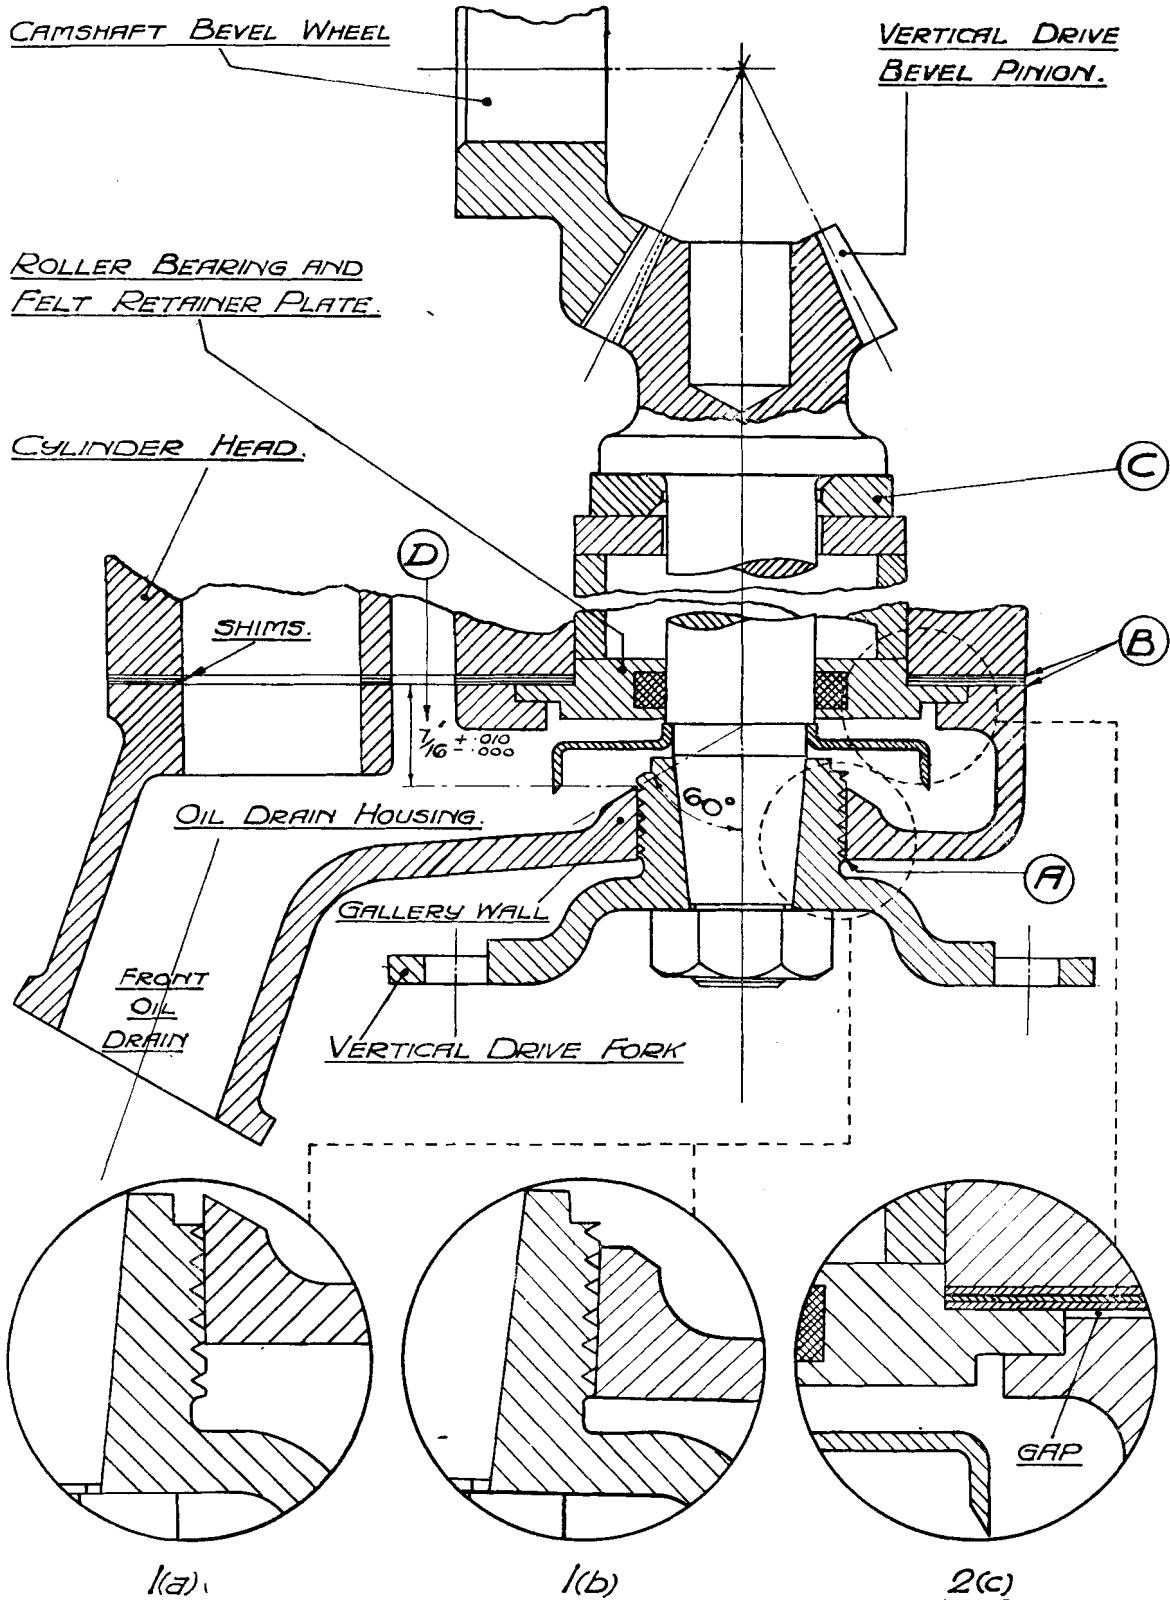
**OIL LEAK AT VERTICAL DRIVE**

1. Between the oil drain housing and vertical drive fork, marked "A" on the illustration.
2. Between the cylinder head face and oil drain housing face, marked "B" on the illustration.

1. (a) The oil return thread of the vertical drive fork below the top of the oil drain housing gallery wall. Refer to illustration 1 (a).  
(b) The oil drain housing gallery wall flat at the top instead of having a sharp edge (chamfer angle 60°). Refer to illustration 1 (b).  
(c) Front oil drain pipe choked.
2. (a) Shims badly torn, as a result of being passed over the stud threads, or buckled.  
(b) The cylinder head and oil drain housing faces either damaged or bearing slight machining marks.  
(c) The roller bearing and felt retainer plate standing proud of the oil drain housing, preventing the housing from seating on the shims. Refer to illustration 2 (c).
3. Too great a quantity of oil allowed to drain from the cylinder head into the vertical drive housing.

1. (a) Either the oil drain housing gallery wall is too deep (see "D" on the illustration), in which case the housing is to be renewed, or a thicker thrust washer (marked "C" on the illustration) is to be fitted. The correct depth of the thrust washer is from .171 in. to .179 in. (Part Numbers P110/210 or P110/211). If it is found that a very thin washer has to be changed for one of the correct depth, then the difference between their depths is the required amount of extra shimming necessary between the oil drain housing and cylinder head faces, bearing in mind that the gears must mesh on their correct pitch line.

(b) If the oil drain housing gallery wall has a flat at the top instead of a sharp edge, or if this wall is too deep for the vertical drive fork, the housing should be replaced by a new one.

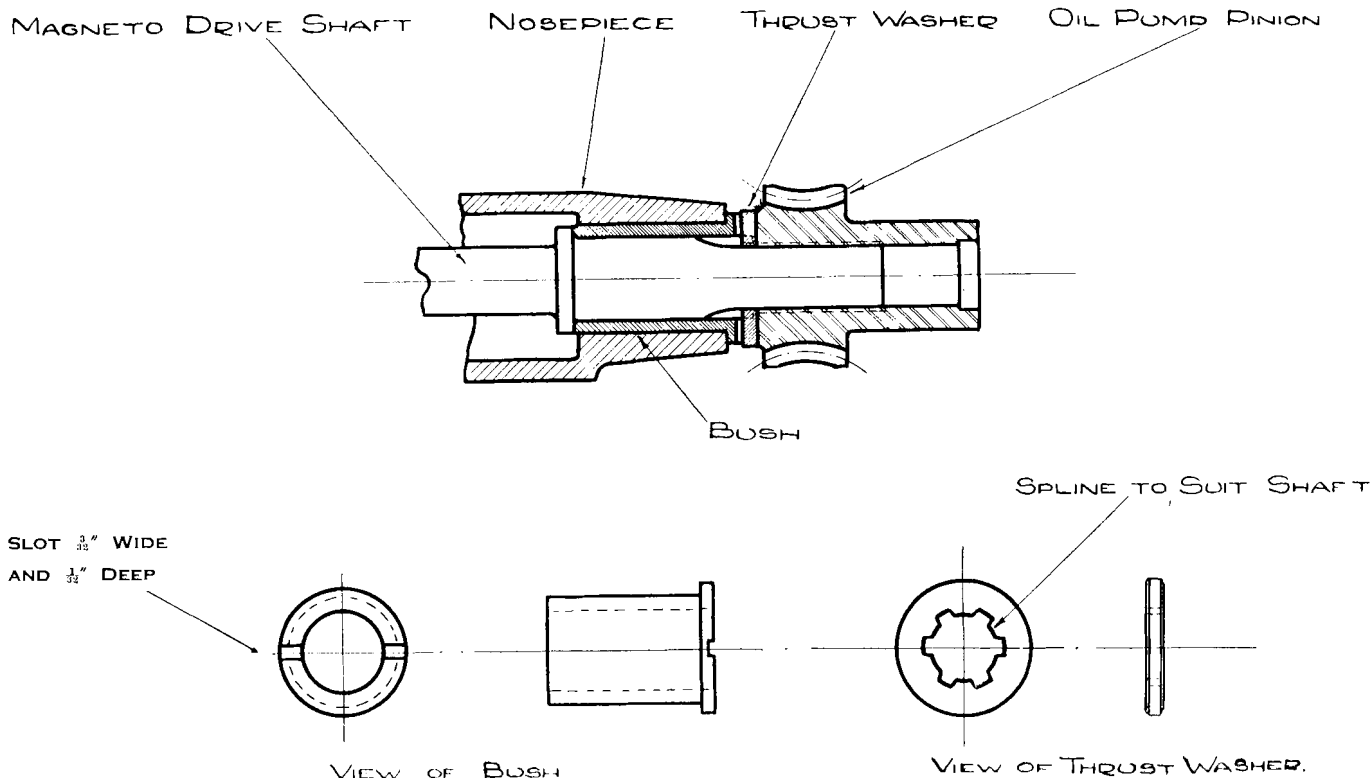
It has been found that the magneto drive thrust washer has been cutting into the splined shaft, causing it ultimately to fail.

Immediate action is necessary to obviate this, and the present washer is to be replaced by a modified one, as shown in the sketch, the washer being splined to the shaft. As the new type of washer has plain faces, oil grooves must be cut in the face of the bush to dimensions as shown in the drawing.

In all probability it will be necessary at the time of modification to change the splined shaft, as wear in the initial stages takes place very rapidly.

The modified washer (Part No. MG.348/298) and splined shaft (Part No. MG.348/227) may be obtained on application being made to the Claims Department.

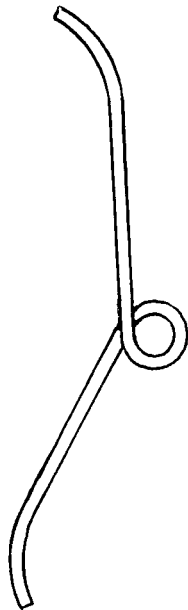
PART NO. M.G 412/115

As a result of a few complaints of failure of clutch operating disc springs, it has been decided to discontinue the use of the springs to Part No. MG.412/116 and to substitute three more springs to Part No. MG.412/115, all six springs thereby being of the same type.

Replacement springs may be obtained in exchange for the obsolete springs on application being made to our Claims Department.

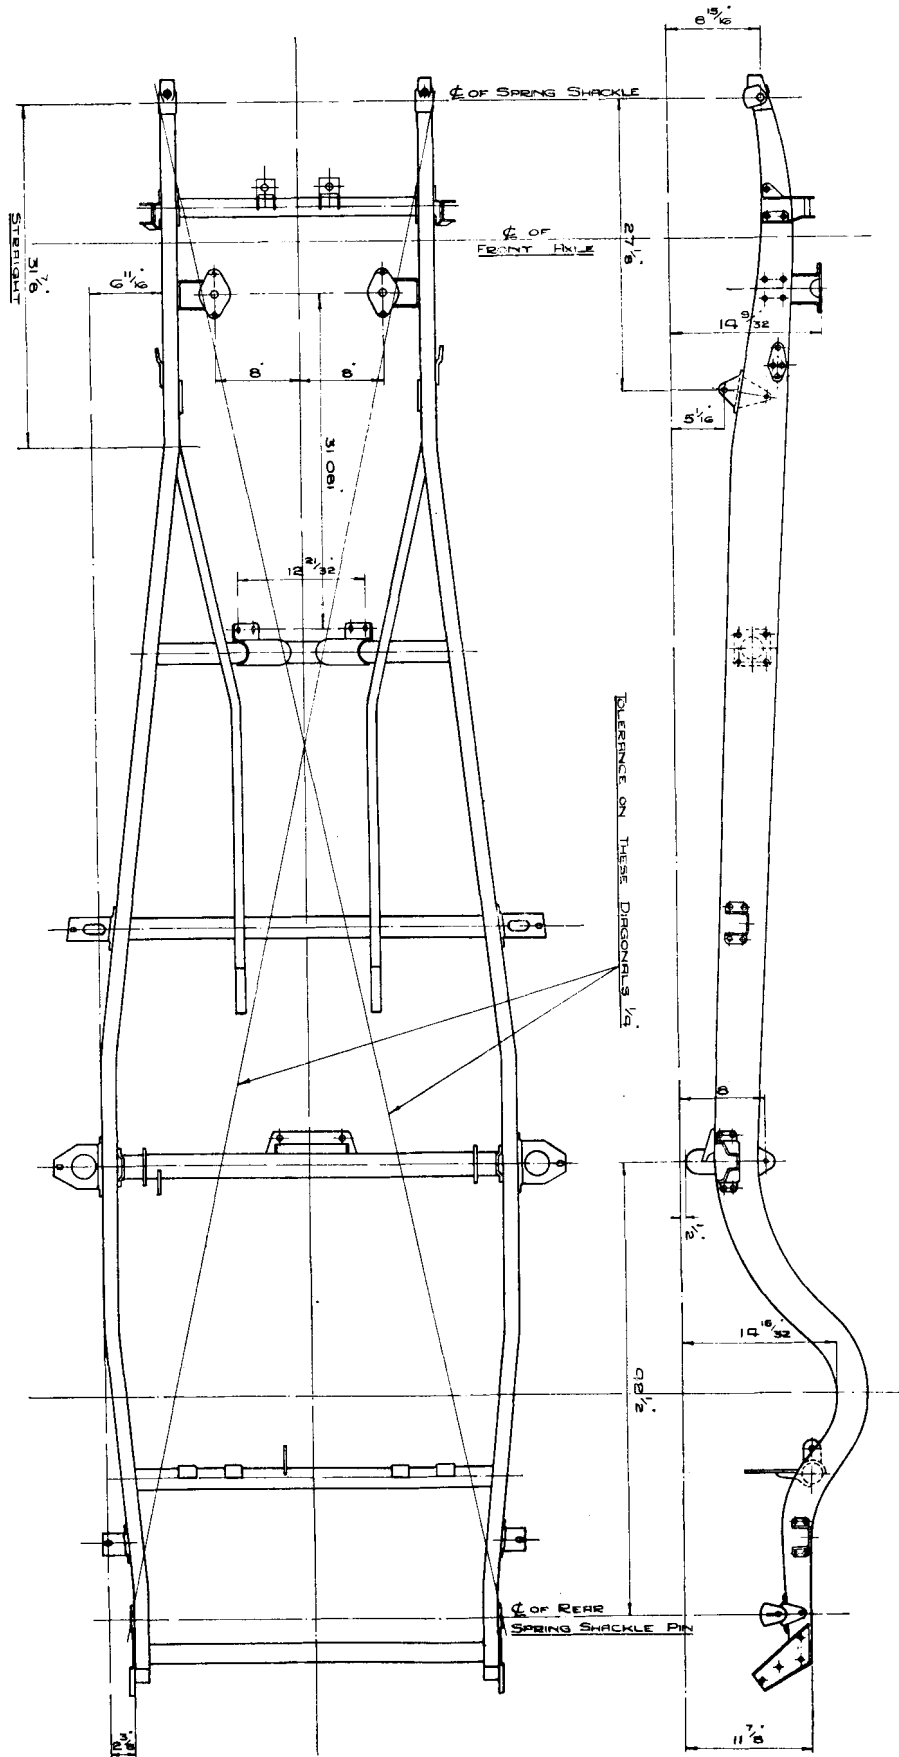
CHASSIS DIMENSIONAL DRAWING

It has been pointed out that the Chassis Dimensional Diagram at present appearing in the Instruction Manual for the 1½-Litre VA. Type is inaccurate. The discrepancies have now been rectified and the correct diagram is given below.
