Service Information

Published by
The M.G. Car Company Ltd.
Abingdon-on-Thames

INDEX (Sheet 1)

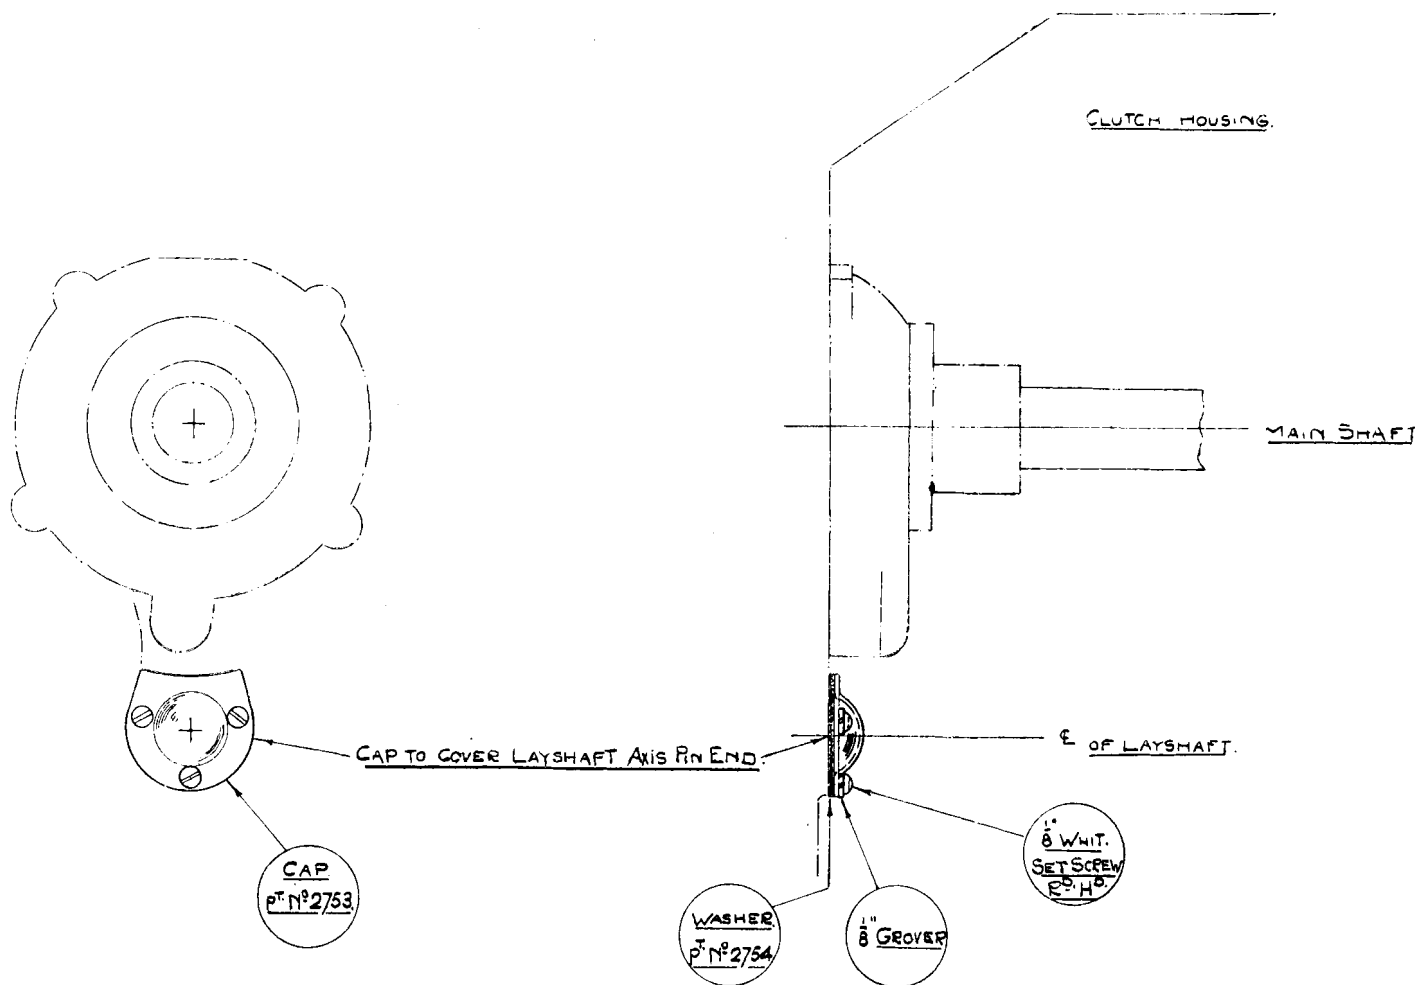
On all these models a gearbox is used having a double-helical constant mesh and third speed, also sliding gears for the other ratios. It has been found in service that an escape of oil into the clutch housing may occur through the front layshaft axis pin, which is pressed into the case.

This trouble is not very prevalent, but when it is found a small cover fitted with a washer and three screws can be fitted to prevent a recurrence.

The drawing herewith (Service Blue Print No. 147) gives particulars of the cover, screws and washer, and also shows its location on the gearbox.

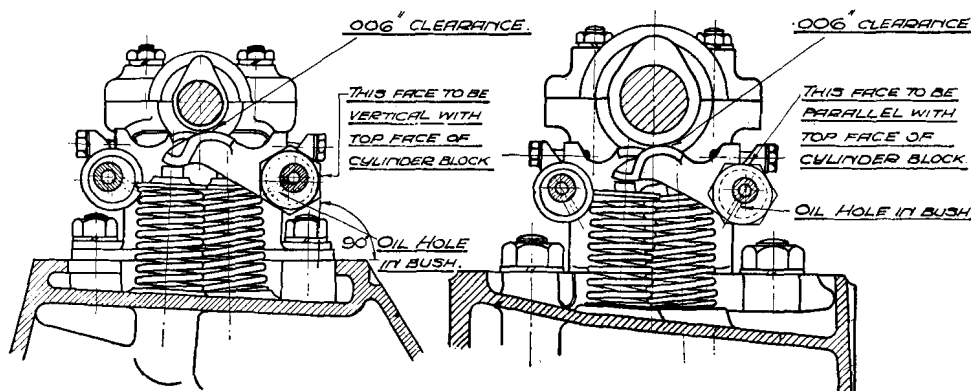
It is possible for a person not acquainted with the engine to set the rockers in various wrong positions which will cause considerable variation of timing on the corresponding valve.

1. Set the rocker eccentric bush in the position shown in Fig. 1 for the J. Type and that as shown in Fig. 2 for the K., L., PA., N., KN. and PB. Type models.
2. Insert the correct feeler gauge between the valve rocker and the cam.
3. Shorten or lengthen the valve stem until it just reaches the rocker. It is not possible, owing to the probability of wear of the rocker face, cam face or valve, to give a definite length of the valve stem.

FIG. 1
SHOWING POSITION OF
ECCENTRIC BUSHES FOR
J. MODELS

FIG. 2
SHOWING POSITION OF ECCENTRIC
BUSHES FOR K., L., PA., N., KN.
AND PB. MODELS

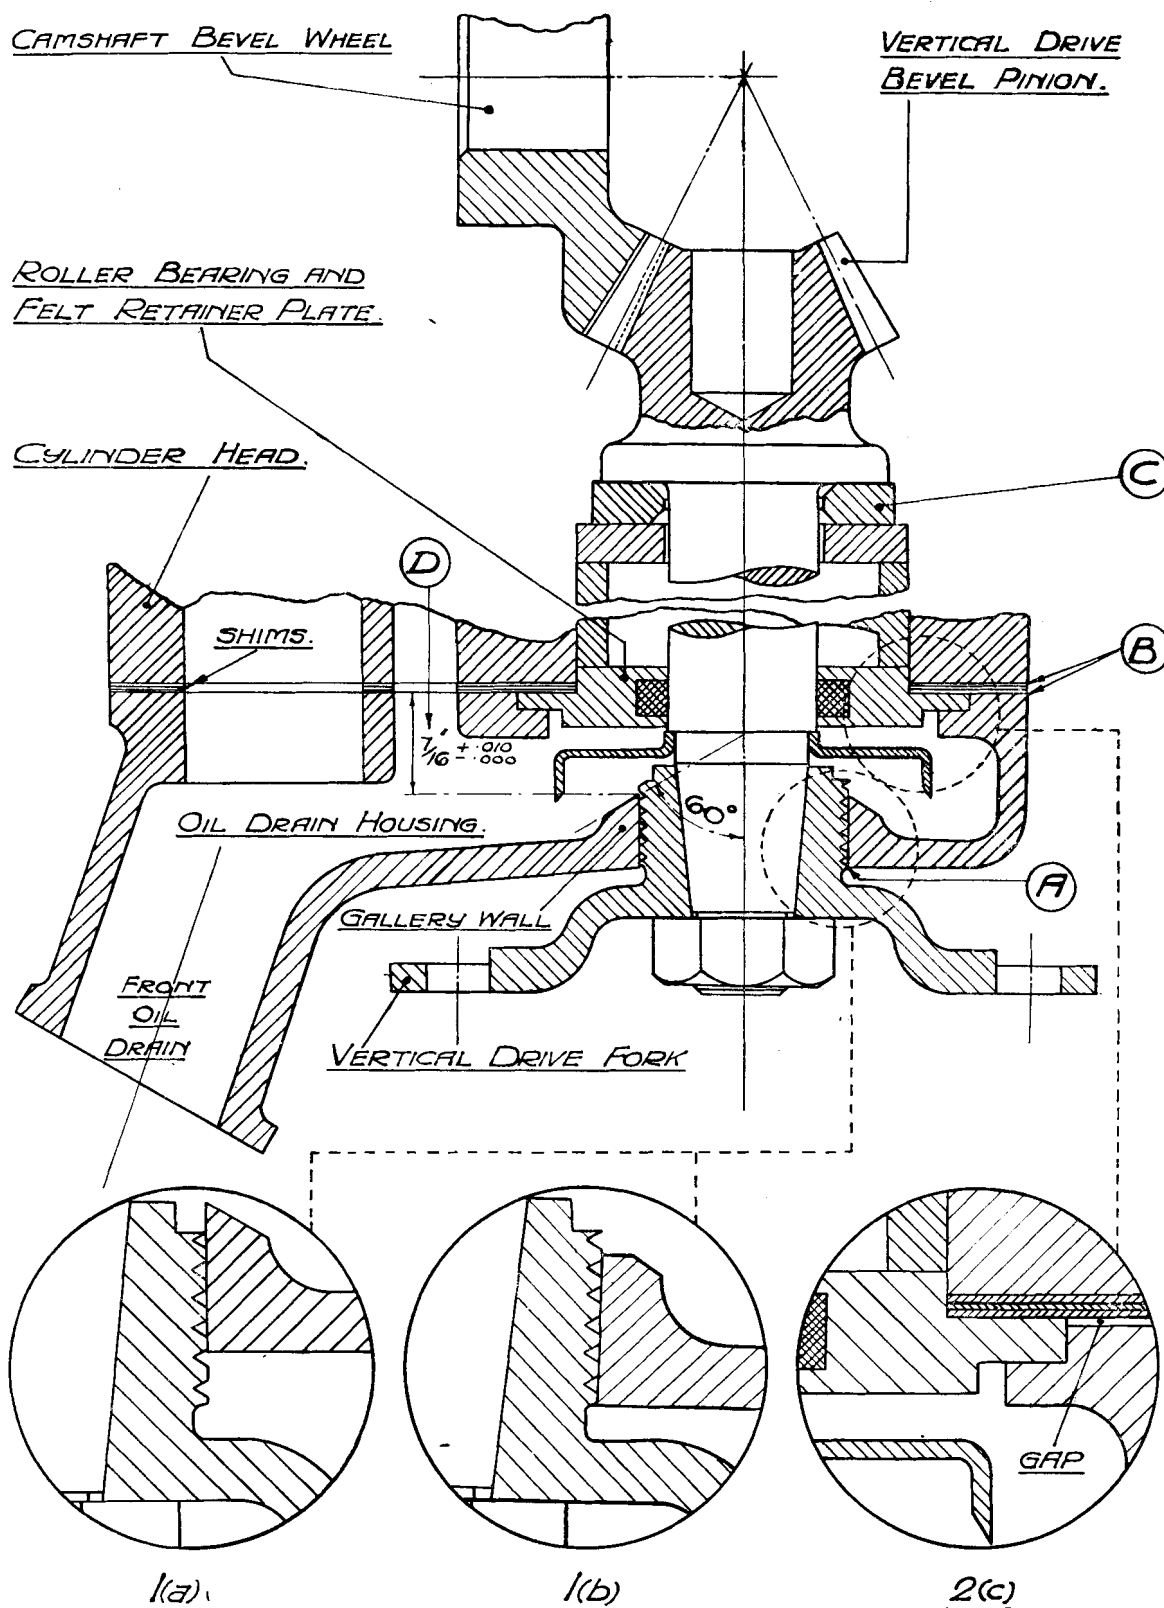
1. Between the oil drain housing and vertical drive fork, marked "A" on the illustration.
2. Between the cylinder head face and oil drain housing face, marked "B" on the illustration.

1. (a) The oil return thread of the vertical drive fork below the top of the oil drain housing gallery wall. Refer to illustration 1 (a).
(b) The oil drain housing gallery wall flat at the top instead of having a sharp edge (chamfer angle 60°). Refer to illustration 1 (b).
(c) Front oil drain pipe choked.
2. (a) Shims badly torn, as a result of being passed over the stud threads, or buckled.
(b) The cylinder head and oil drain housing faces either damaged or bearing slight machining marks.
(c) The roller bearing and felt retainer plate standing proud of the oil drain housing, preventing the housing from seating on the shims. Refer to illustration 2 (c).
3. Too great a quantity of oil allowed to drain from the cylinder head into the vertical drive housing.

1. (a) Either the oil drain housing gallery wall is too deep (see "D" on the illustration), in which case the housing is to be renewed, or a thicker thrust washer (marked "C" on the illustration) is to be fitted. The correct depth of the thrust washer is from .171 in. to .179 in. (Part Numbers P110/210 or P110/211). If it is found that a very thin washer has to be changed for one of the correct depth, then the difference between their depths is the required amount of extra shimming necessary between the oil drain housing and cylinder head faces, bearing in mind that the gears must mesh on their correct pitch line.

(b) If the oil drain housing gallery wall has a flat at the top instead of a sharp edge, or if this wall is too deep for the vertical drive fork, the housing should be replaced by a new one.

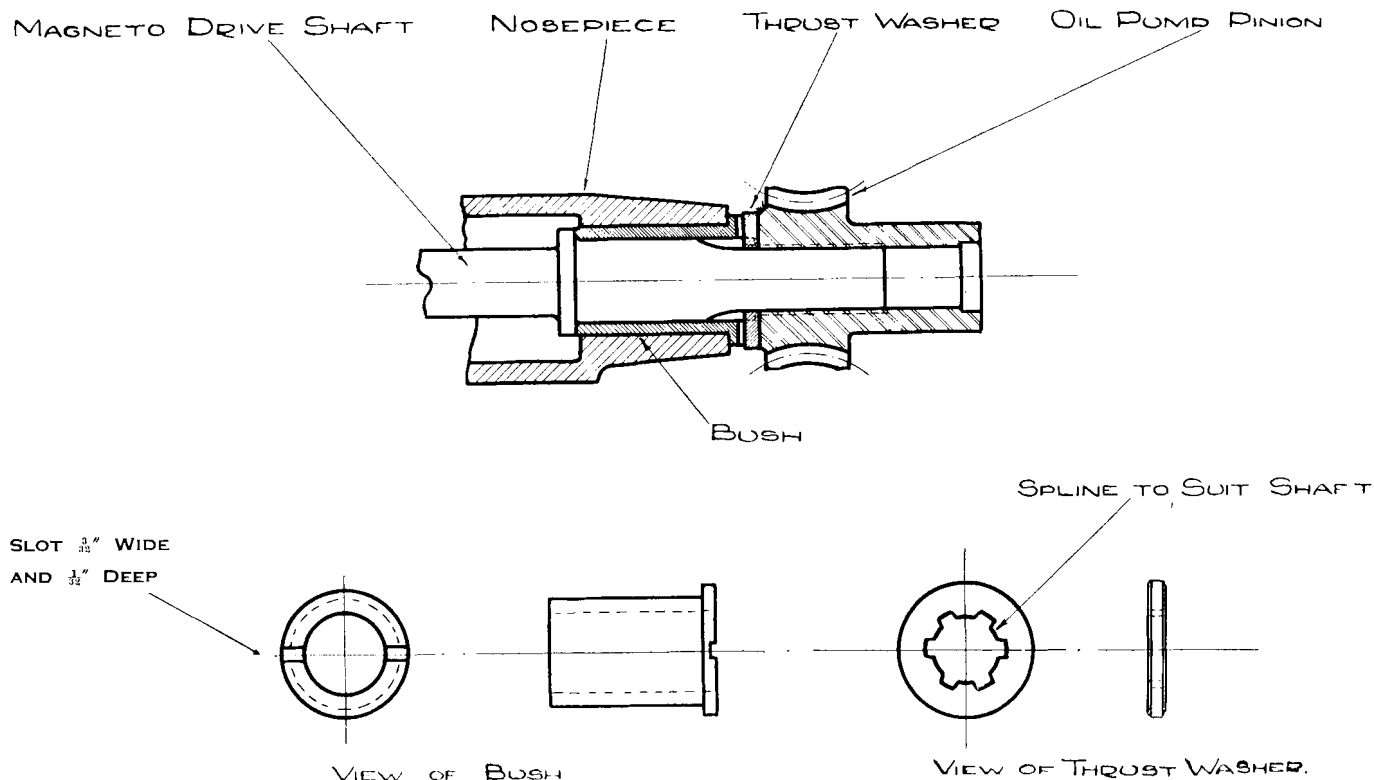
It has been found that the magneto drive thrust washer has been cutting into the splined shaft, causing it ultimately to fail.

Immediate action is necessary to obviate this, and the present washer is to be replaced by a modified one, as shown in the sketch, the washer being splined to the shaft. As the new type of washer has plain faces, oil grooves must be cut in the face of the bush to dimensions as shown in the drawing.

In all probability it will be necessary at the time of modification to change the splined shaft, as wear in the initial stages takes place very rapidly.

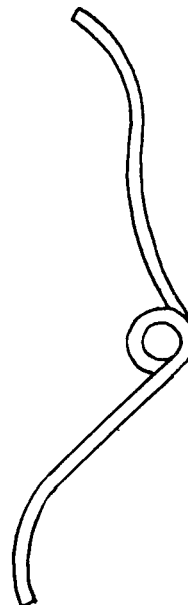
PART NO. MG 412/116

(OBSOLETE)

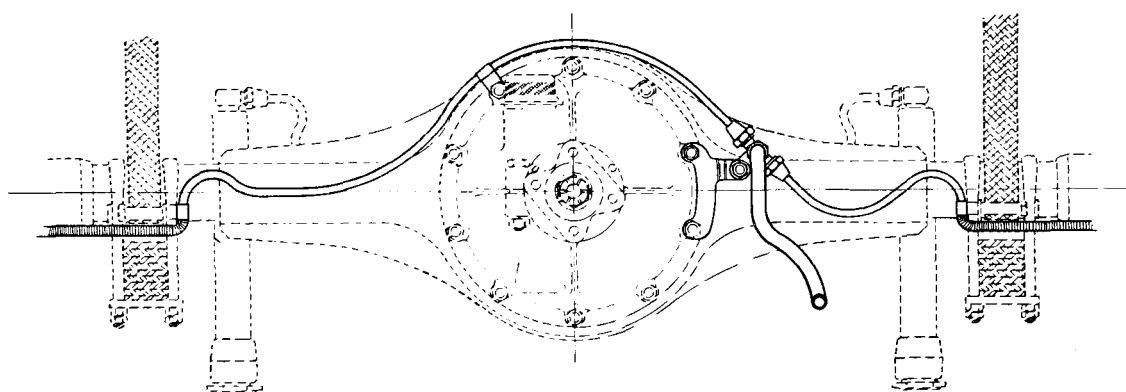
ORIGINAL ARRANGEMENT OF LOCKHEED PIPES.

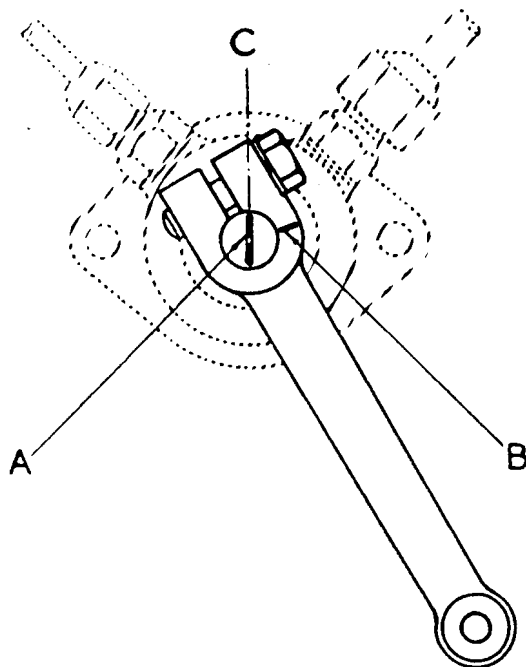
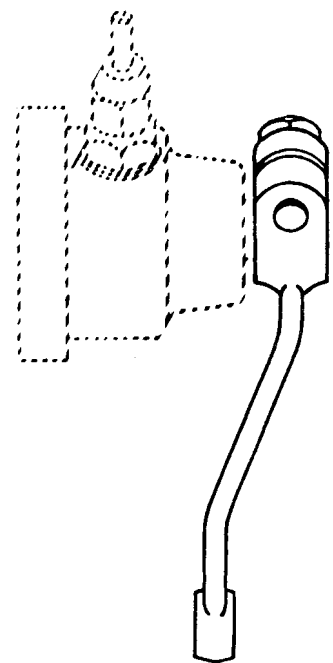
It has been brought to our notice that the fitting mark "A" on the pump shaft is incorrectly positioned in relation to the mark "B" on the operating lever. This gives an unequal travel either side of the central position, sometimes allowing the pump rotor to foul the valve chamber on the maximum rebound position of the axle.

This is a very small but very important modification and all Service Stations are requested to check and readjust the pump units on all 1½ Litre (VA. Type) cars that are in for service.

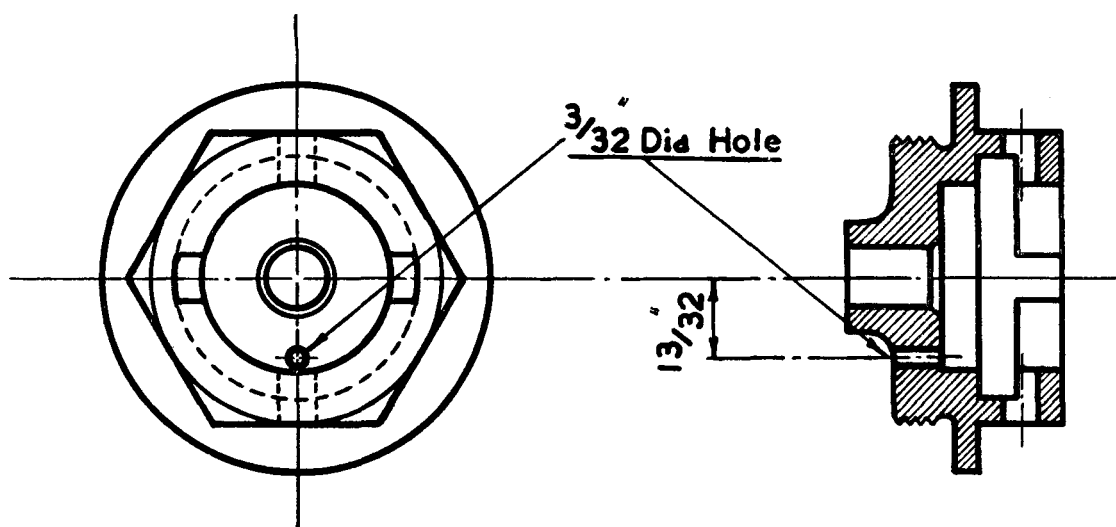
A peculiar case of a Two-Litre (SA. Type) axle being drained of oil in a very short mileage due to a leak from the nosepiece has been examined.

Service stations are advised, therefore, that if this difficulty is experienced this hole should be drilled.

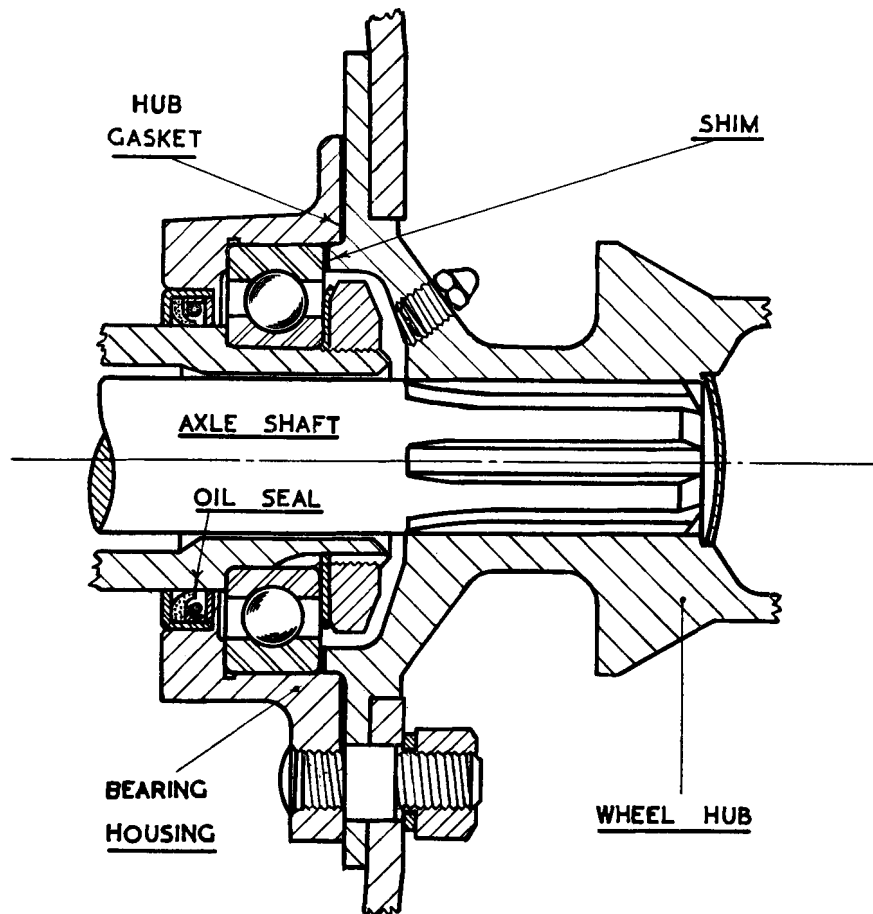
In certain circumstances, due to machining limits, the introduction of this gasket gives a clearance between the ball race and the dowel of the hub, which allows the bearing housing to float on the ball race. To overcome this a shim should be fitted as illustrated in the sketch below. SA. Type Two-Litre Shim .010 in. (Part No. MG663/157), and TA. Series Midget and VA. Type 1½-Litre Shim .007 in. (Part No. MG689/143).

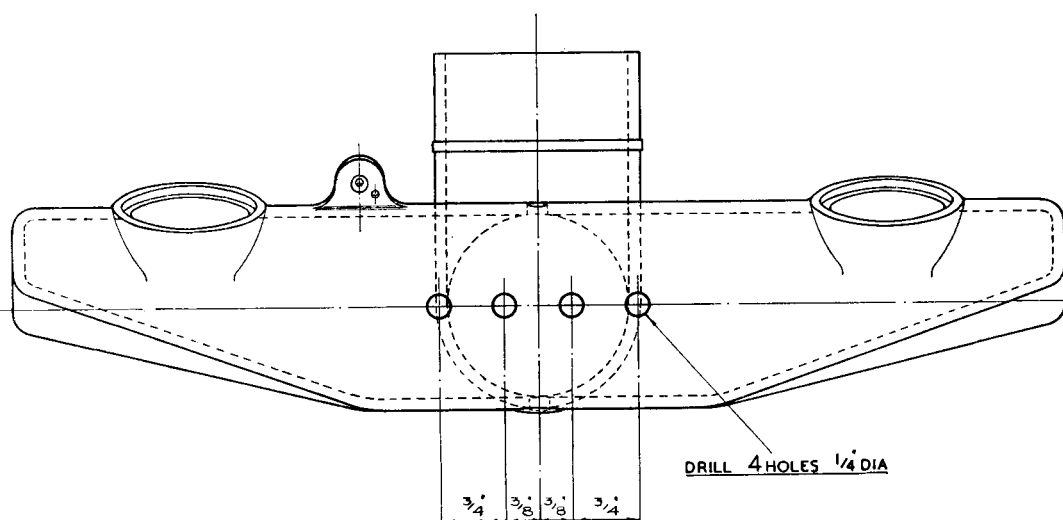
A modification to the air cleaner manifold has been made to improve the engine performance between the speeds of 1000—3500 r.p.m.

It is very necessary thoroughly to clean the manifold after drilling, and of course the air cleaner should be detached from the manifold to eliminate the possibility of aluminium drillings getting into the air cleaner filter.
