J2 TECHNICAL ARTICLE

Number 182

ON THE SUBJECT OF CLUTCH STOPS

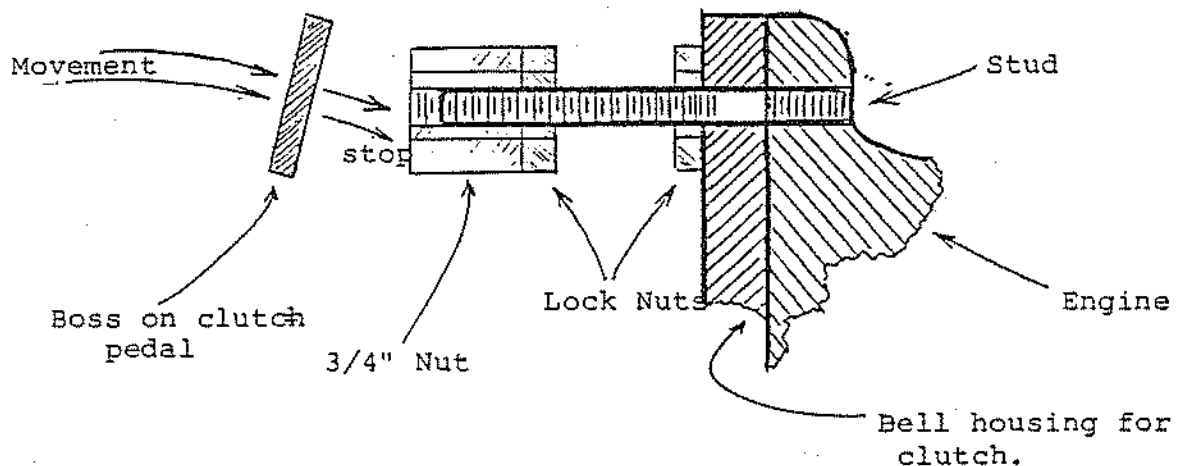
Both Authorities verified that the original clutch pedal stop was the stud at the pedal location. This stud was one which held the bell housing for the clutch onto the engine. There was a lock nut on the stud to secure the bell housing to the engine. A second lock nut was placed onto the stud followed by the 3/4" long nut. This long nut was adjusted to the correct place to stop the clutch pedal travel and the lock nut brought up to secure the setting. See the sketch below.

One thought by one owner was a 1/4" BSF bolt with lock nut held in a tapped hole in the clutch pedal boss. That sounded logical and worthy to explore. Even though the original parts manual indicated a bolt and lock nut for the clutch pedal stop, neither I nor my "authorities" in England could find cars with holes drilled and tapped in the boss on the clutch pedal.

One authority stated that the whole assembly is not really needed and most owners run without it.
