## J2 TECHNICAL ARTICLE

Number 84

### THE TECALAMITE LUBRICATION SYSTEM (CENTRAL LUBE SYSTEM)- RIGHT SIDE

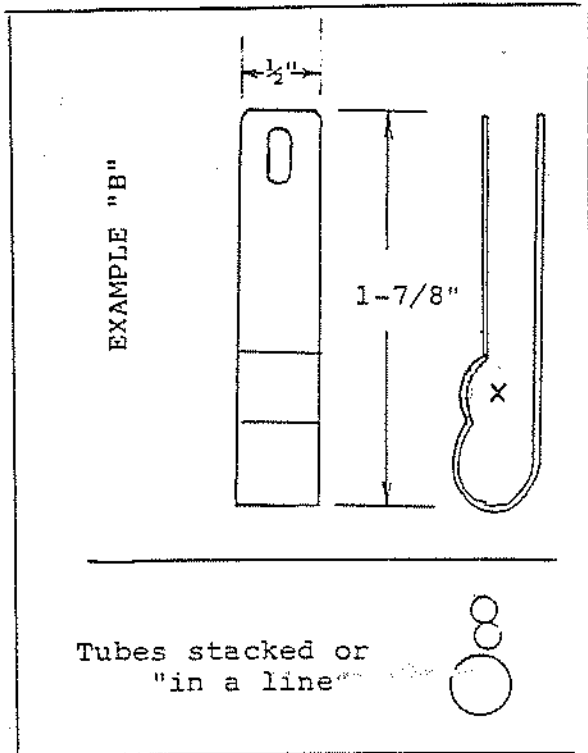
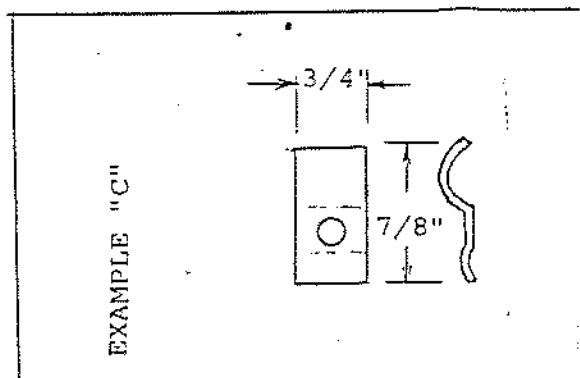
The last clamping point for the lube tube is just 6 inches from the end of the chassis. The fuel line has departed so the rear spring trunion tube is all by itself. This holding point is a clip. It is a steel clip like example "C" and is painted black.
