## **MG P Type Differential Rebuild.**

I'll start by saying that this document is a record of what I did to the differential on my PA. Having never rebuilt a differential, I'm not implying that what I have done is correct, or cannot be improved upon in any way.

Early on I decided that I would apply recommended modifications during the rebuild, namely, fitting an oil seal into the pinion cover, replacing all the pinion assembly bearings with taper roller bearings and a similar replacement of the crown wheel assembly bearings with taper roller bearings.

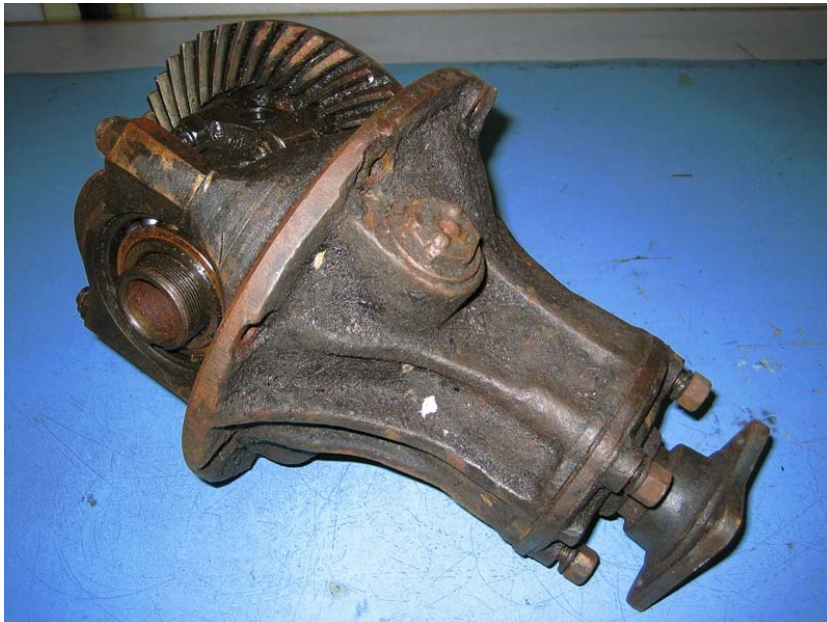
The unit I started with.

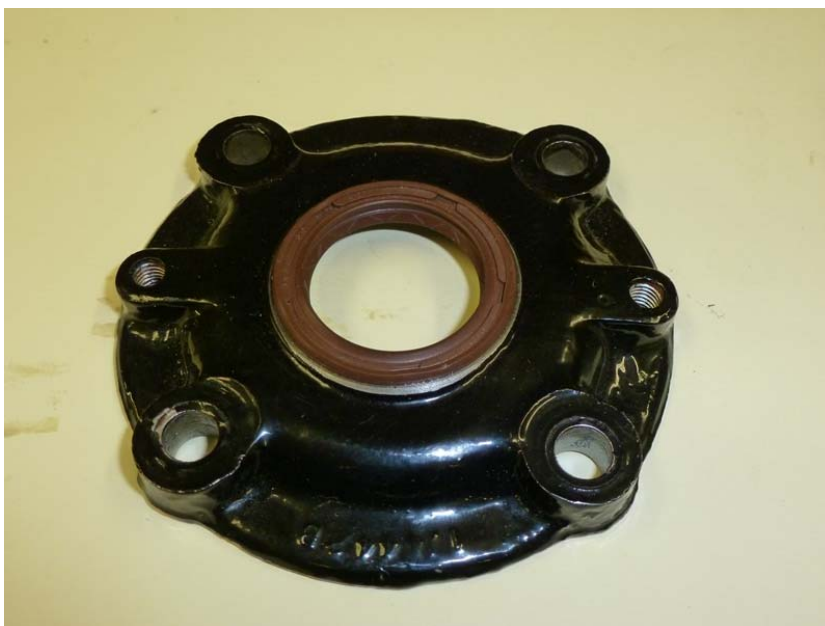
The oil seal was a double lip, Viton oil seal purchased from Simply Bearings.

Size : Outer diameter 40mm  
Inner diameter 30mm  
Thickness 5mm

Oil seal in place :

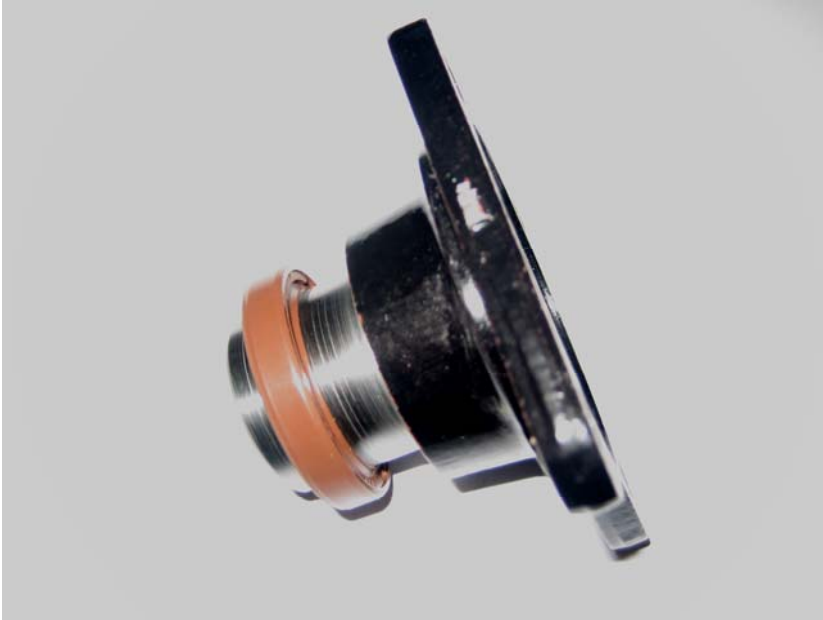
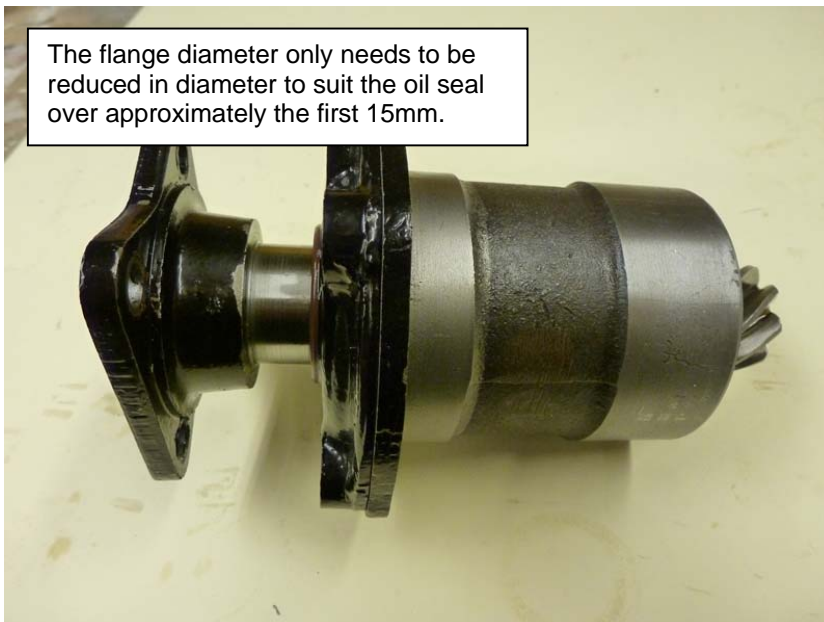
The propshaft flange was also turned down in diameter to 30mm to suit the Internal diameter of the oil seal.

The surface was polished as much as possible to ensure a smooth surface for the oil seal to run on. It should be noted that once the whole pinion assembly is together, only a very small area of the flange needs to be actually reduced in diameter. Only the first 15mm probably needs to be reduced in diameter. (furthest left 15mm in the photo below)

The flange diameter only needs to be reduced in diameter to suit the oil seal over approximately the first 15mm.

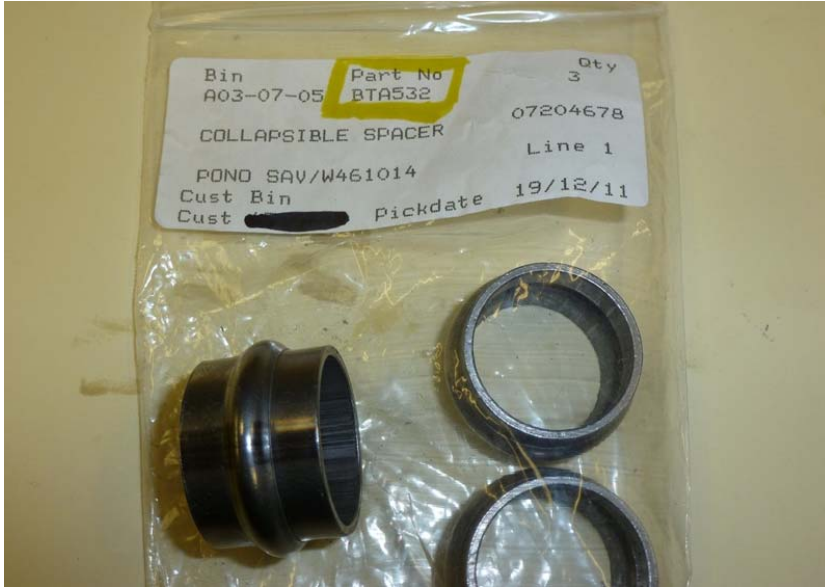
The spacer between the two bearings used was an MG Midget/Austin Healey Sprite differential collapsible spacer.

Part number BTA532, purchased from Moss. ([www.moss-europe.co.uk](http://www.moss-europe.co.uk))

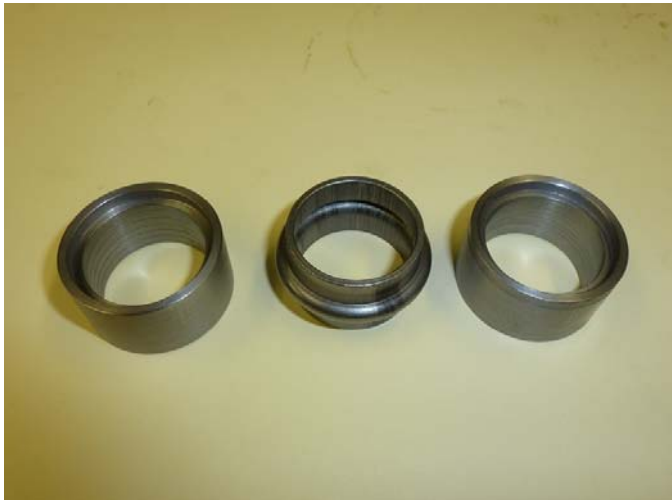
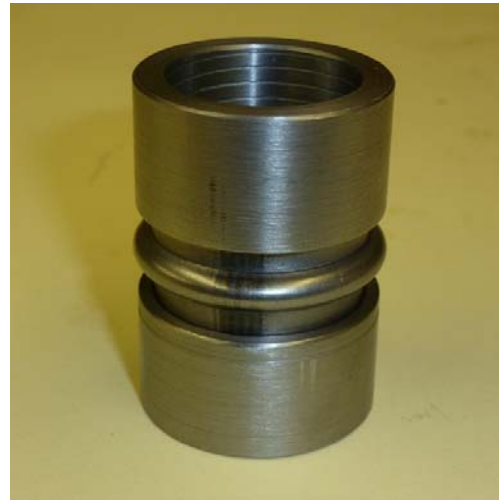
The collapsible spacer and the two carriers :

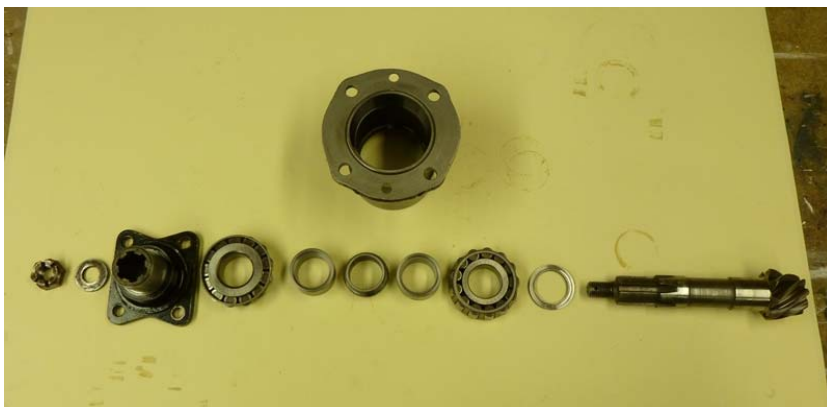
There are all the parts of the pinion carrier assembly.

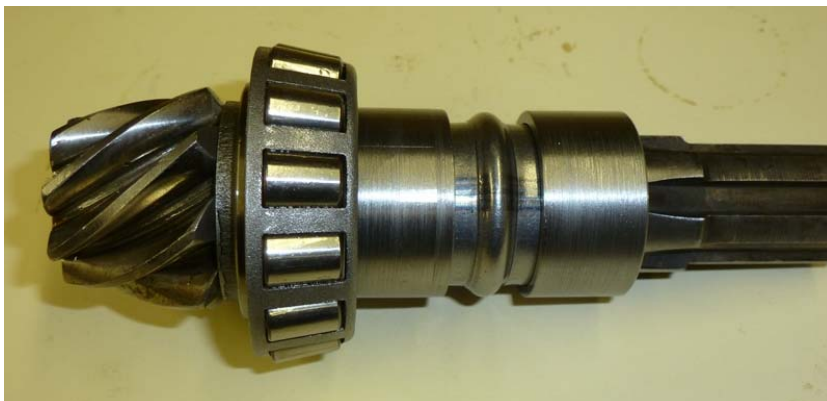
Stage 1 : Fit the two Bearing outers into the pinion carrier.

Stage 2 : Starting from the gear end, fit the small spacer, the bearing inner, the first collapsible spacer carrier, the collapsible spacer and finally the second collapsible spacer carrier to achieve the following :

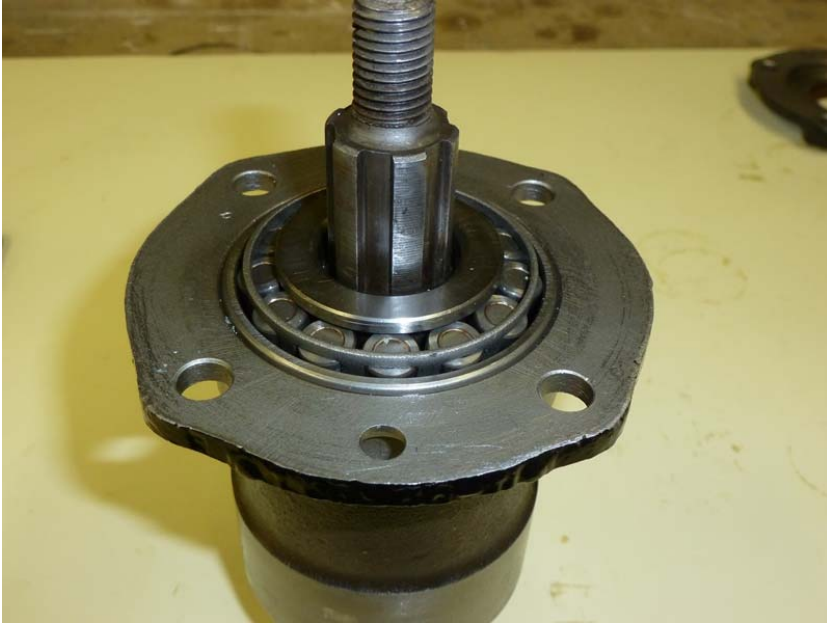
Stage 3 : Fit the pinion gear assembly into the carrier, and fit the second bearing inner.

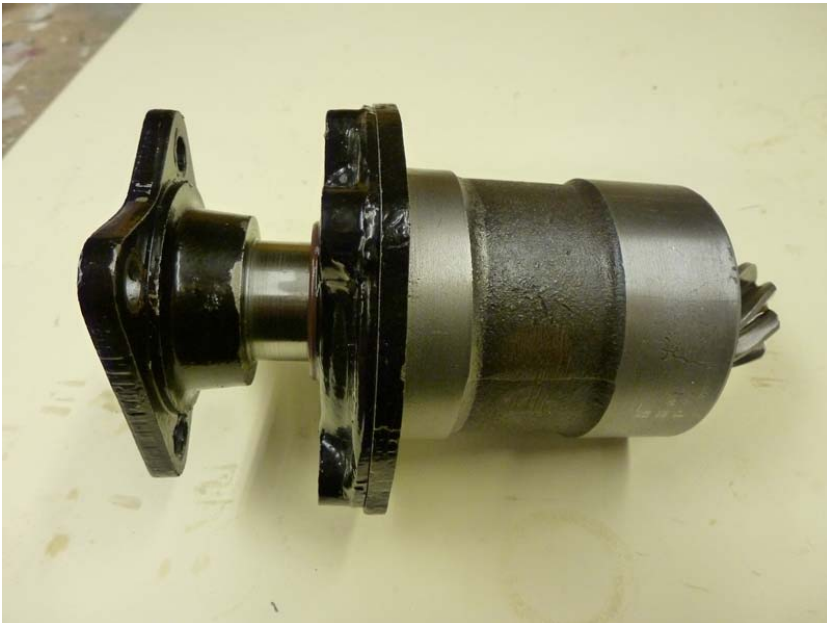
Stage 4 : Fit the Cover, the Flange and the washer and nut to finish the assembly. Only tighten the nut up finger tight to start with.

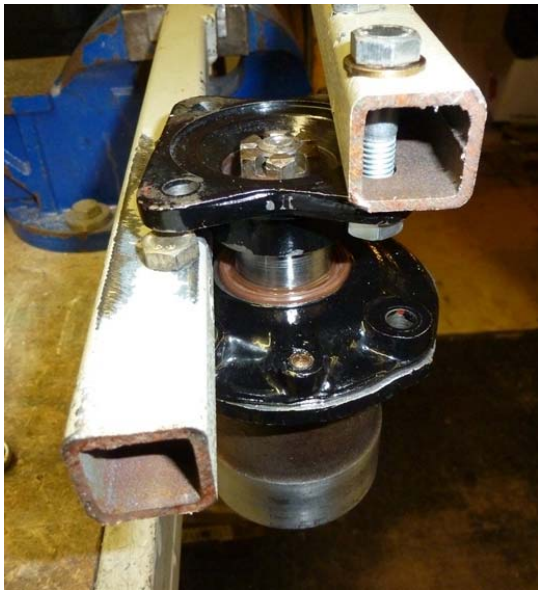
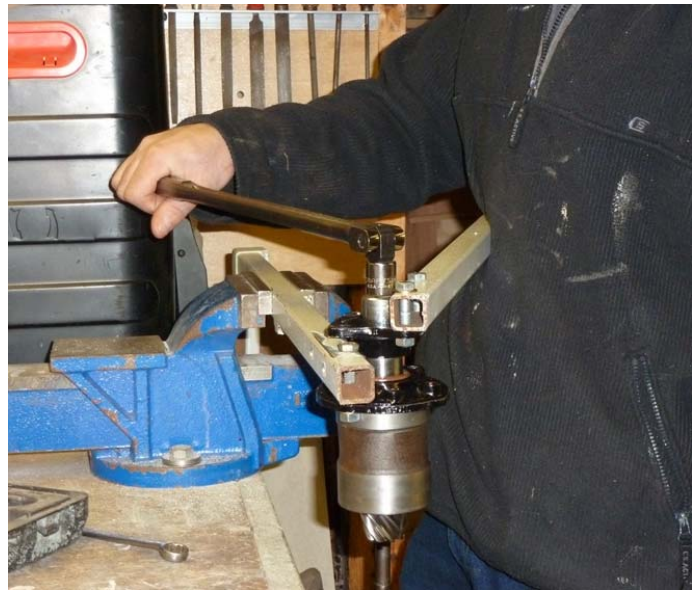
Tightening was achieved by using a couple of lengths of 1” square tube. One bolted to the carrier assembly, the other to the flange.

I could then use a long breaker bar on the flange nut and bear the flange bar against myself to tighten.

In the end I followed some advice I found on a Timken Taper Bearing Tech Tip sheet which, for wheel bearing setups, that it is tightened up until there is a slight bind, then it is backed off  $\frac{1}{6}$  to  $\frac{1}{4}$  of a turn.

I tightened it up until I could see no movement in the assembly, then backed it off between the  $\frac{1}{6}$  to  $\frac{1}{4}$  of a turn and the castellations of the nut lined up with the hole in the shaft for the split pin. Don't forget to fit the split pin through the nut at the propshaft flange.

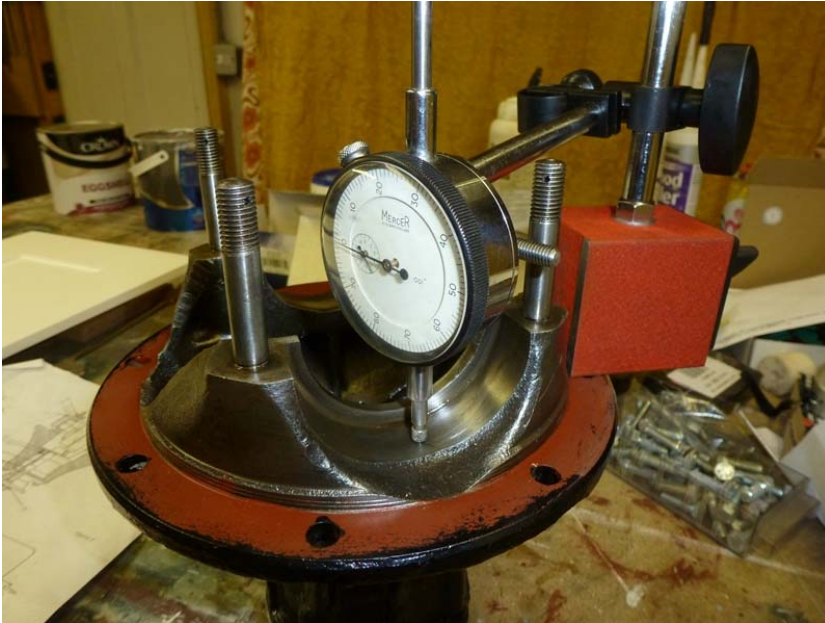
Initially I used a DTI and a magnetic base fixed to the side of the nose piece to get the measurement, but it didn't quite work out.

The DTI travel needs to be quite long without any shims.

Whilst I could easily find the lowest point of the bearing track and zero the gauge, swinging the gauge around when the base was attached to the nose piece, to the end of the pinion wasn't possible without inaccuracies.

I'm sure that with a surface plate and the DTI on the magnetic base it would be possible to get a good measurement, so long as the diff assembly is carefully setup on the surface plate so the two bearing tracks are completely parallel with the surface plate.

Fortunately I got the measurement done at the company I work at in the machine shop. They have a surface plate and a very expensive looking measurement device that provided the distance between the pinion end and the lowest point of the bearing track very easily.

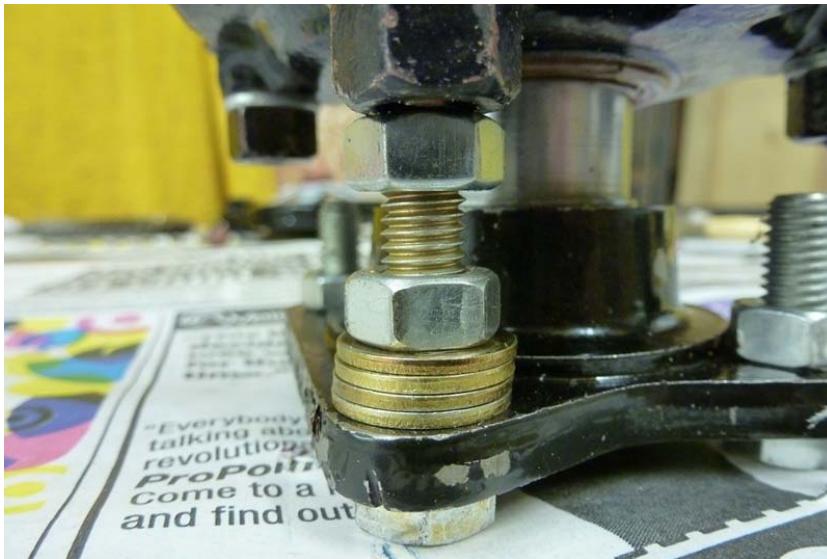
'MG Road Cars' recommends putting the flange in a vice but the problem I found whether it was held in a vice, or sat on the flange on a table was that when rocking the crown wheel, the main diff casing would move in relation to the flange and affect the reading.

So I simply used a bolt just long enough to clear one of the pinion cover nuts, and then wound up a nut to lock the flange against one of the pinion cover nuts as shown below. This gave a reliable 'rock' of the crown wheel without anything else moving and affecting the reading.

The whole assembly could then be placed on a bench rather than in a vice.

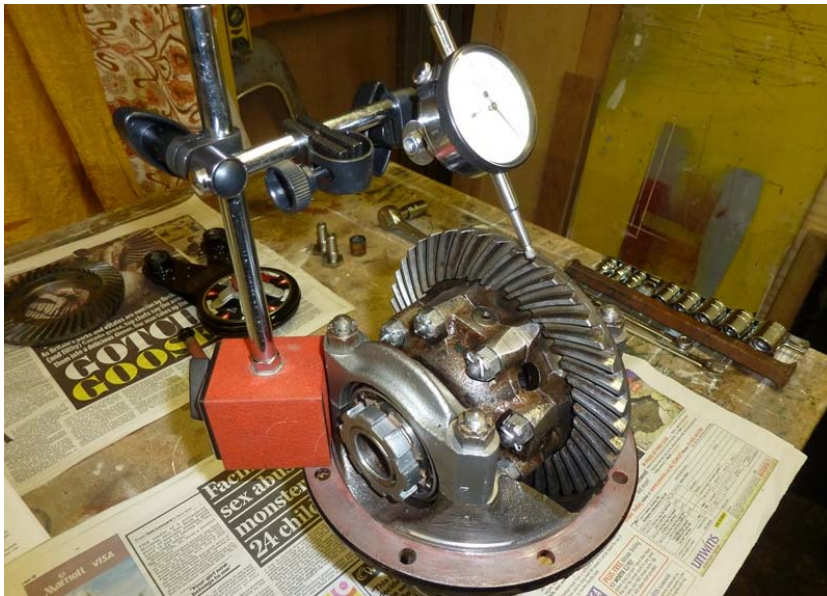
I then moved the DTI to the teeth of the crown wheel gear as shown in the next photo.

I could find no engraved reference anywhere on the crown wheel as to what the backlash should be set to, so followed 'MG Road Cars' and set it to "at least 0.005".

In order to attempt to maintain the taper roller bearing loading, every time I needed to make a backlash adjustment, the crown wheel assembly was moved by undoing one castellated nut by a set number of castellations, and tightening up the other by the same number of castellations.

The backlash was checked at multiple points around the crown wheel. I ended up going round the crown wheel several times making measurements and adjustments.

This took some time – unlocking the flange, rotating the crown wheel a bit, relocking the flange, taking the backlash measurement and adjusting as necessary. I found a reasonably large variation, and set to a minimum of 0.005"

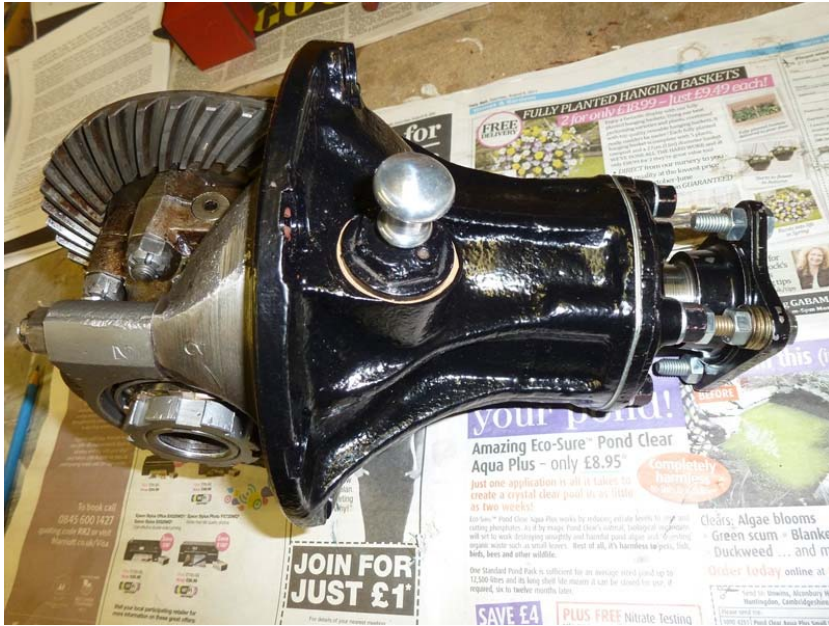
And the end result -
