*Service Information*

*Published by*  
**The M.G. Car Company Ltd.**  
*Abingdon-on-Thames*

Date of Issue: March, 1936

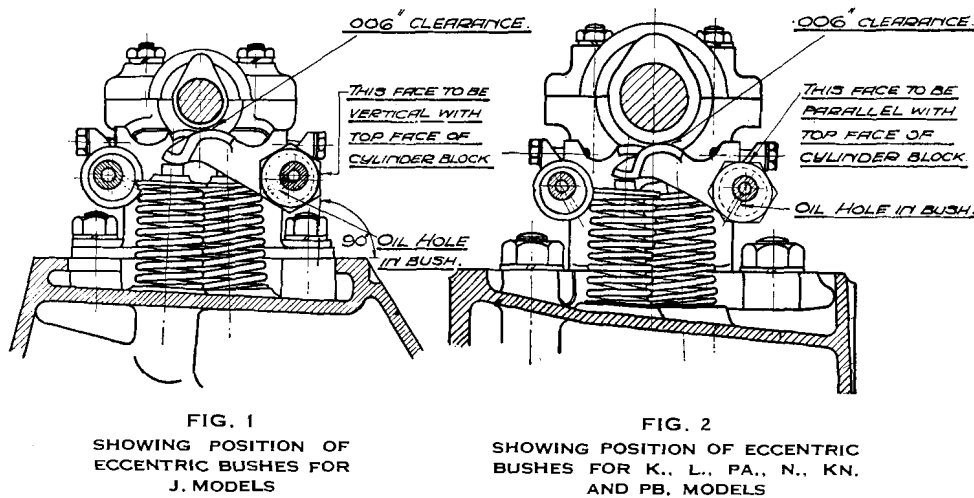
It is possible for a person not acquainted with the engine to set the rockers in various wrong positions which will cause considerable variation of timing on the corresponding valve.

1. Set the rocker eccentric bush in the position shown in Fig. 1 for the J. Type and that as shown in Fig. 2 for the K., L., PA., N., KN. and PB. Type models.
2. Insert the correct feeler gauge between the valve rocker and the cam.
3. Shorten or lengthen the valve stem until it just reaches the rocker. It is not possible, owing to the probability of wear of the rocker face, cam face or valve, to give a definite length of the valve stem.

*Note* :—To shorten the valve stem, grind the end carefully on a fine emery wheel, using a "V" block to steady the valve. The end of the stem must be square or very slightly raised in the centre.

To lengthen the valve stem, regrind the valve with its seat, providing the amount is not more than .001 in. to .002 in. If in excess of this measurement it is advisable to re-cut the valve seat with a suitable seating cutter.

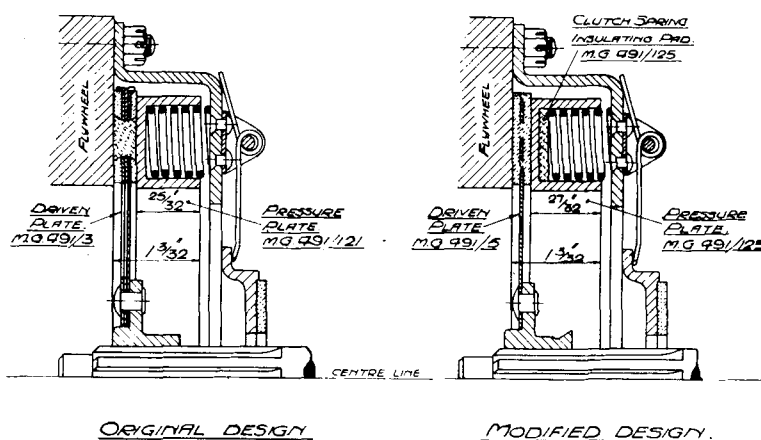
The original design consisted of a driven plate having three discs with the linings secured by means of cork inserts and tabs on the periphery of the discs turned over to prevent the lining from being flung off by centrifugal force. The pressure plate used with this driven plate is  $\frac{25}{32}$  in. thick.

The modified design of clutch consists of a driven plate having a single disc with the lining moulded in position, the pressure plate being  $\frac{27}{32}$  in. thick. Insulating pads are inserted in the spring guide holes to protect the clutch springs from heat.

The modification came into production commencing at Engine No. :—

**P.A. Engine No. 2002**  
**N.A. Engine No. 1001**

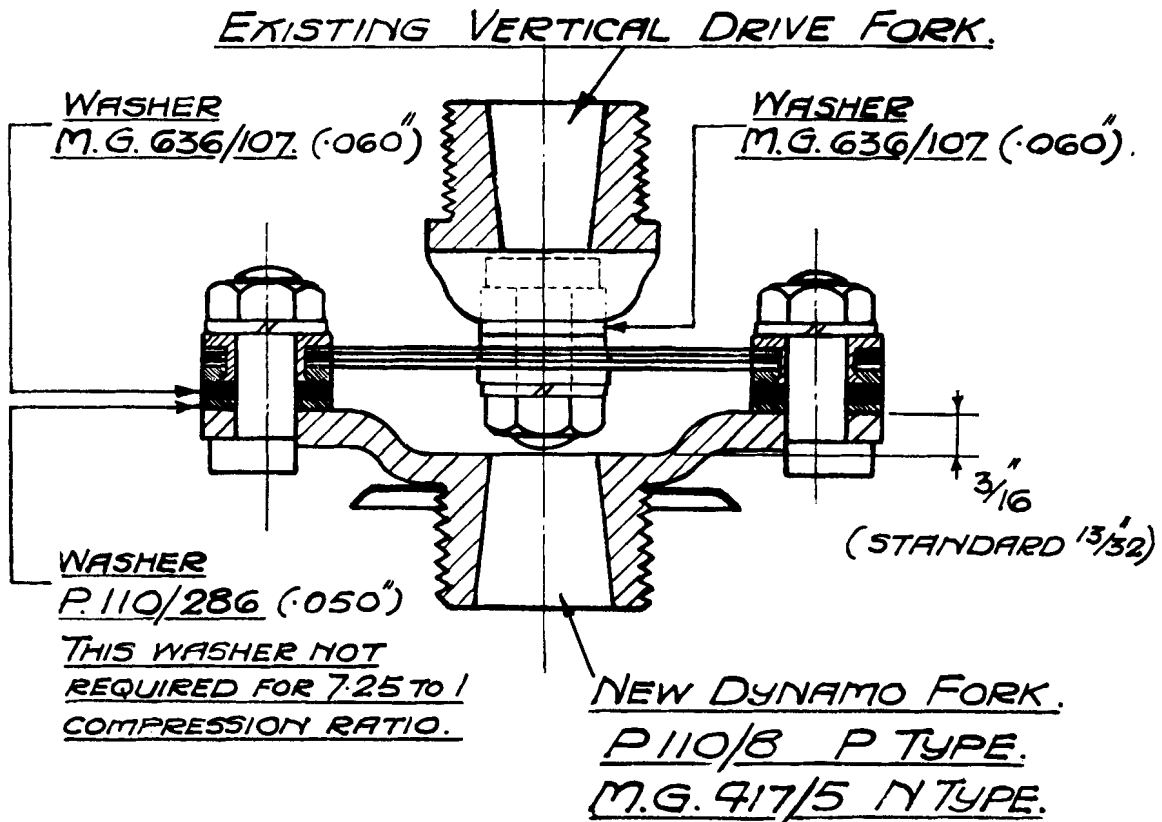
**VERTICAL DRIVE COUPLING ARRANGEMENT.**

To raise the compression ratio to 6.7 to 1 the cylinder head face must be machined to give an overall depth of  $3\frac{9}{32}$  in. instead of the standard dimension of  $3\frac{41}{64}$  in. The standard copper and asbestos gasket is retained, and this is always advisable and is to be preferred to the employment of a very thin steel gasket or no gasket at all, as with both the latter the making of a sound joint is always very difficult unless the operation is carried out by a highly skilled man. It will be appreciated that as a result of raising the compression ratio the dimension between the dynamo and cylinder head is reduced by a similar amount, necessitating the use of a more shallow dynamo drive fork. The sketch indicates the forks required together with the necessary packing washers.

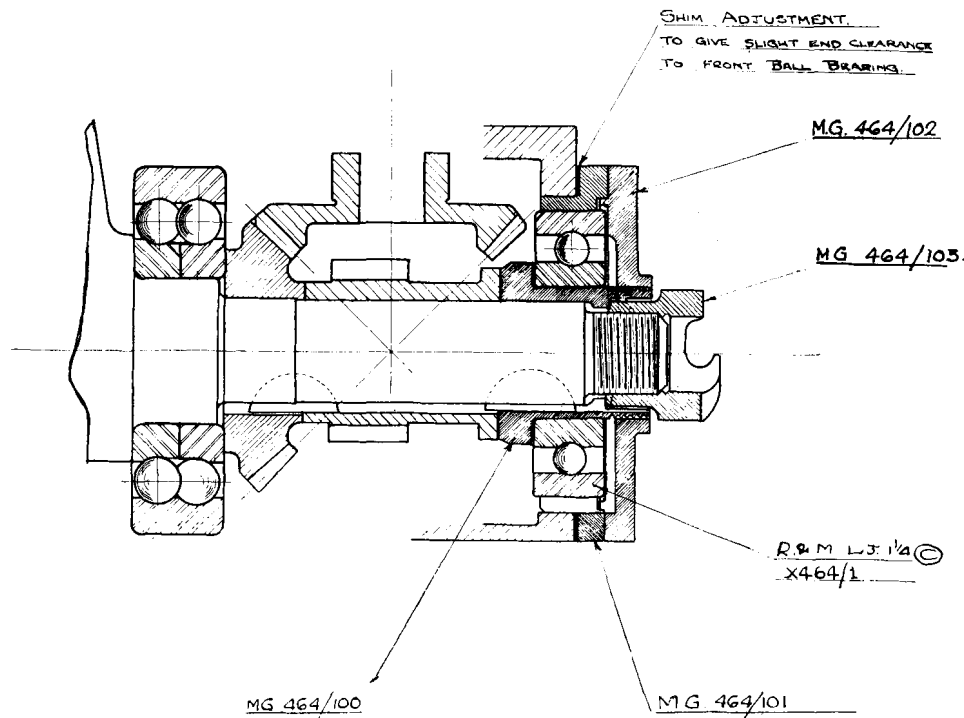
1. Slacken the engine fixings to enable the front end to be dropped sufficiently to allow the engine nosepiece and crankshaft thrust washers to be removed, taking care to support the front end of the engine.
2. The crankshaft must be accurately tested for longitudinal movement and this must not exceed .008 in. If the movement is in excess of .008 in. a new main ball race should be fitted, as the secondary race must not be allowed to take any thrust load.

3. The diagram shows the assembly in detail, the method of shimming, however, is very important and must be carried out very carefully.

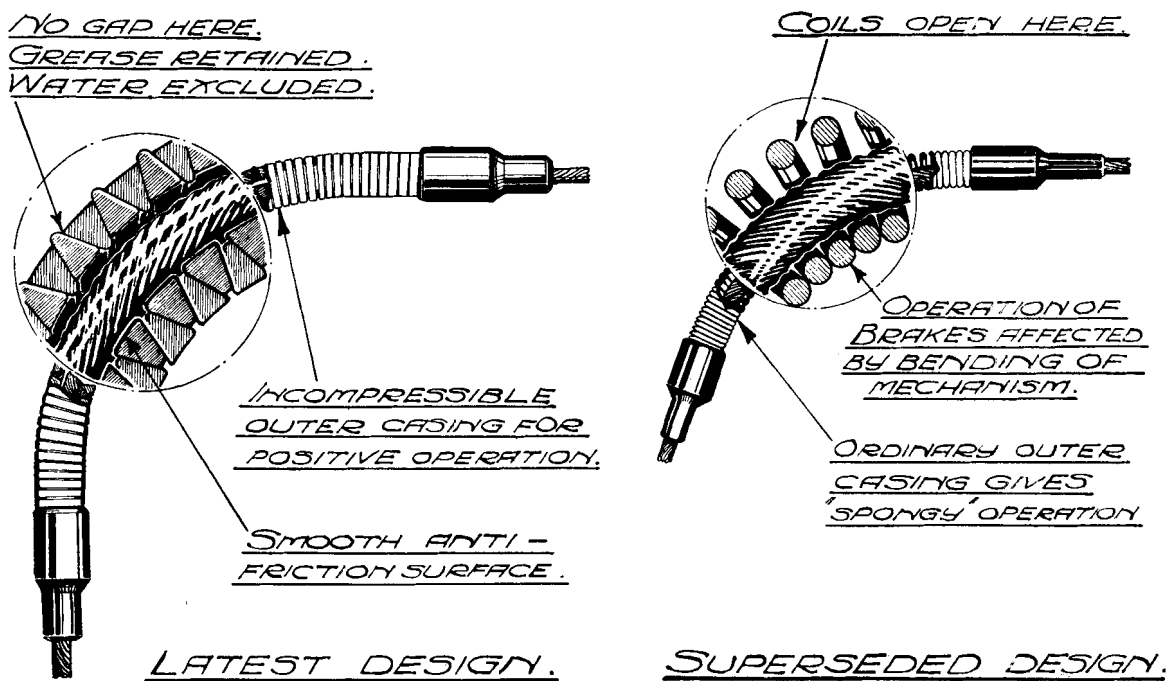
The new type of cable, which is marketed under the trade name of "Bowdenex T," is fitted with an outer casing which is designed to retain the same mean length whether bent or straight, and is, at the same time, incompressible. The sketch below illustrates this point.

It is a matter of considerable importance to ensure that the new cables are fitted in pairs per axle, as one of the new type fitted in conjunction with one of the old type will inevitably result in uneven braking.

LUBRICATION.—A lubricant having a graphite content must be used.

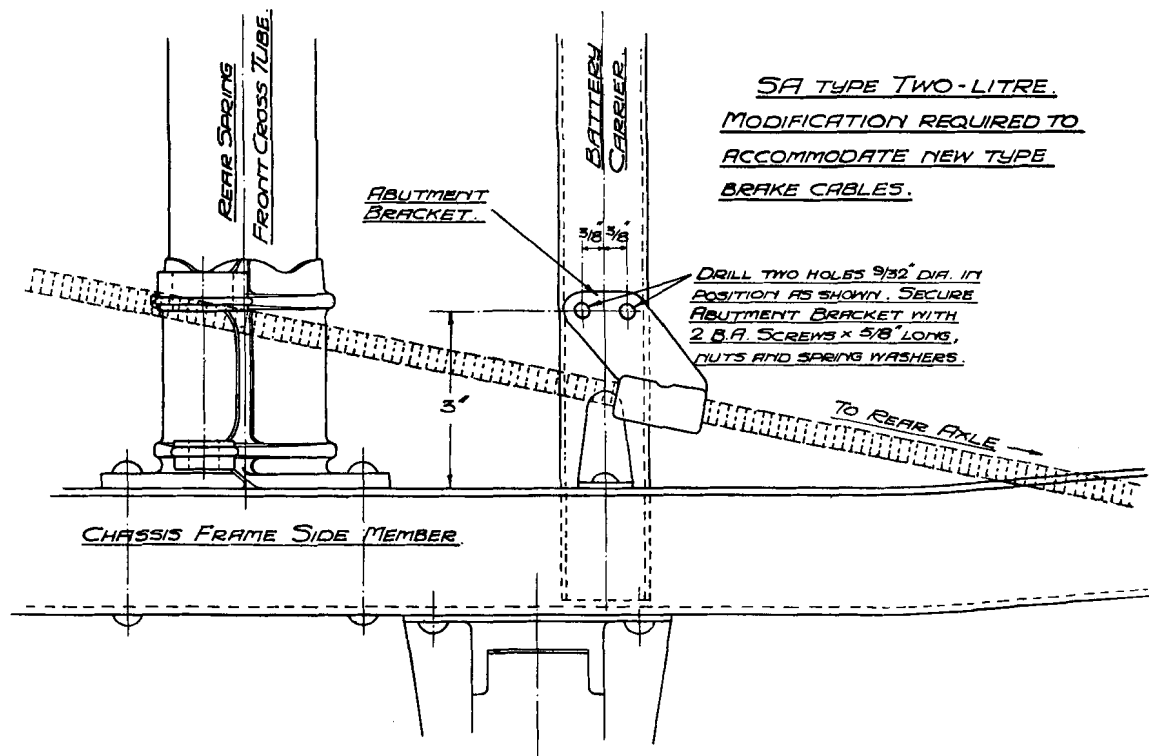
On cars bearing a Chassis Number previous to SA1407, to accommodate the new cables, it will be necessary to drill two  $\frac{9}{32}$  in. diameter holes in the battery carrier to secure each of the abutment brackets. Particulars of this modification are given in the sketch below. The cables being fitted, it only becomes necessary to connect the Tecalemit pipe line to the abutment bracket when the work is complete.

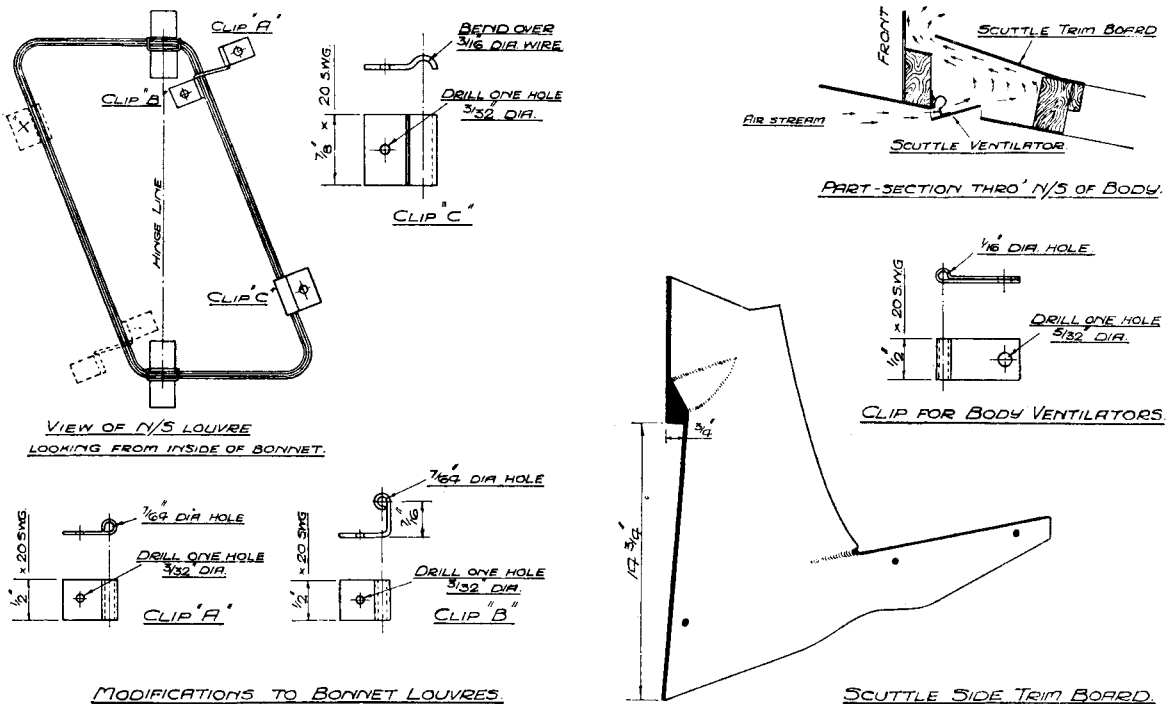
The two rearmost louvres are to be permanently shut by soldering or welding the stop bracket to the louvre marked "X."

The above modifications have been incorporated on production commencing at Body Number 923/3932.

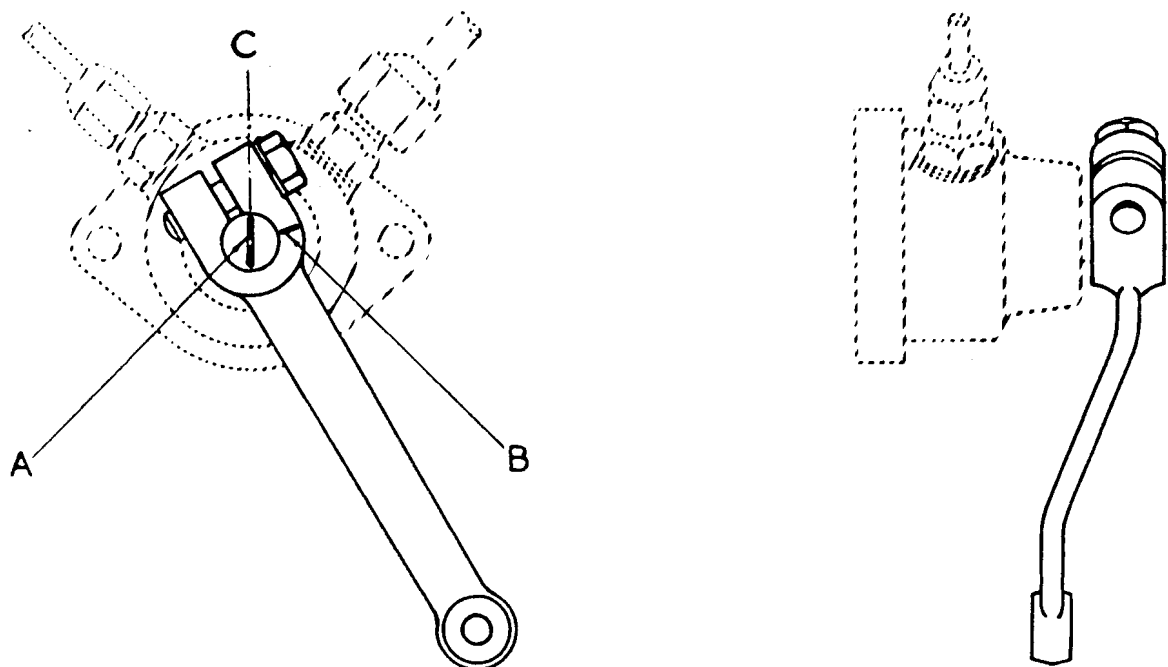
To overcome this difficulty the lever pinch bolt must be slackened and the lever turned clockwise on the shaft until the mark "A" on the shaft lines up with the corner of the lever boss as shown at "C."

This is a very small but very important modification and all Service Stations are requested to check and readjust the pump units on all 1½ Litre (VA. Type) cars that are in for service.

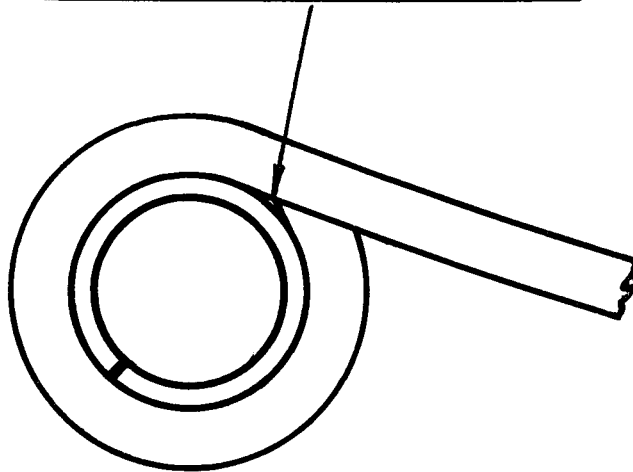
BUSH TO BE FITTED WITH  
SEAM OPPOSITE THIS POINT.

It is essential that the rolled type of shackle pin bush now fitted to the above models is fitted to the spring eye so that the join of the bush does not coincide with the join of the spring eye. If reference is made to the sketch below it will be seen that with the bush correctly fitted loss of lubricant is prevented at this point.

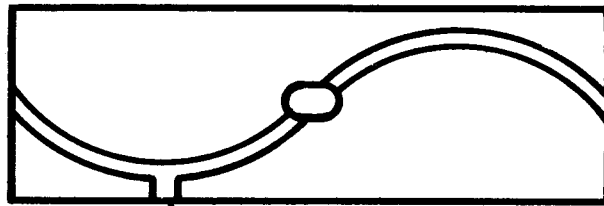
**BUSH TO BE FITTED WITH GROOVE**

**TOWARDS AXLE BEAM**

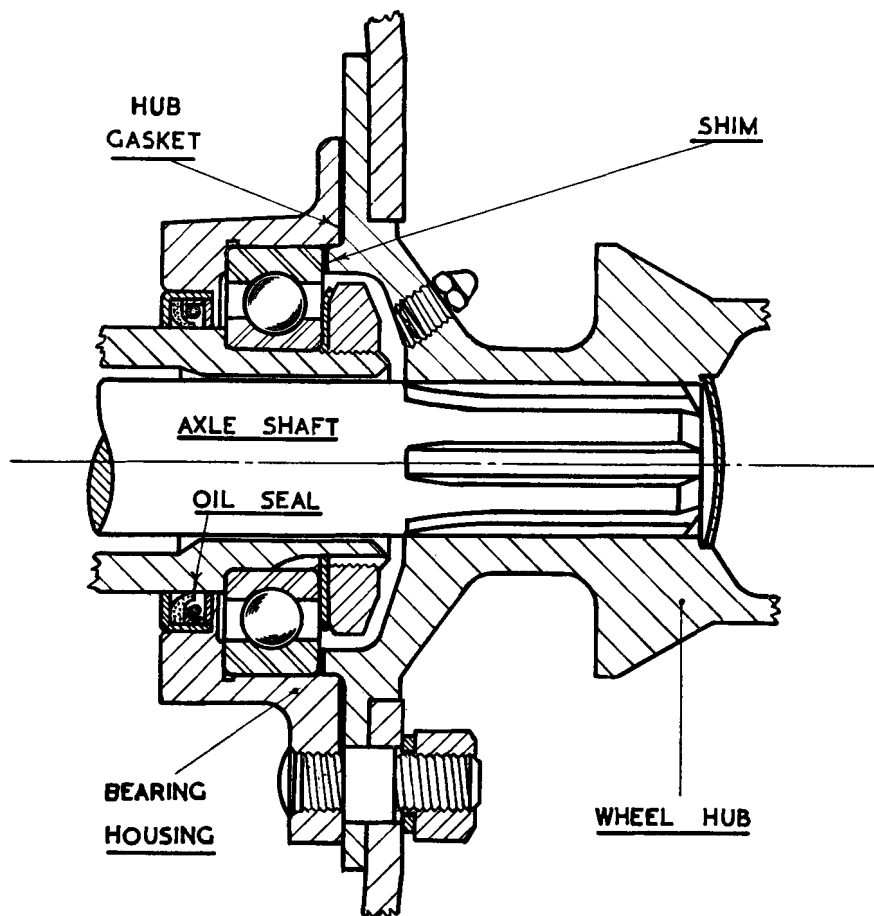
In certain circumstances, due to machining limits, the introduction of this gasket gives a clearance between the ball race and the dowel of the hub, which allows the bearing housing to float on the ball race. To overcome this a shim should be fitted as illustrated in the sketch below. SA. Type Two-Litre Shim .010 in. (Part No. MG663/157), and TA. Series Midget and VA. Type 1½-Litre Shim .007 in. (Part No. MG689/143).

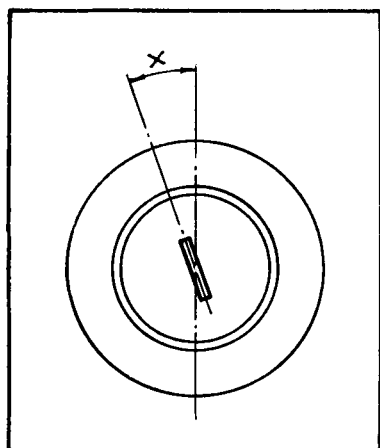
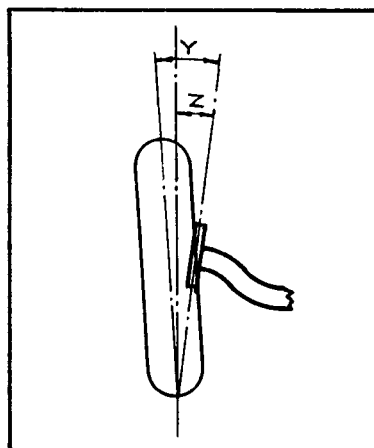
**B = BEAM.  
P = PACKING.  
S = SPRING.**

Model	Castor Angle " X "	Knuckle Angle " Y "	King Pin Angle " Z "
M ... ..	3° (B Nil—P 3°—S Nil)	9°	6½°
D, J, F ... ..	6° (B 3°—P Nil—S 3°)	9°	6½°
L ... ..	7° (B 3°—P 1°—S 3°)	9°	6½°
K, KN, TA ...	6° (B 3°—P Nil—S 3°)	10½°	7½°
P, PB ... ..	8½° (B 3°—P 2½°—S 3°)	9°	6½°
N ... ..	8° (B 3°—P 2°—S 3°)	10½°	7½°
SA ... ..	4° (B Nil—P Nil—S 4°)	10°	8°
VA ... ..	4½° (B Nil—P 1½°—S 3°)	10°	8°
WA ... ..	6° (B Nil—P 2°—S 4°)	10°	8°

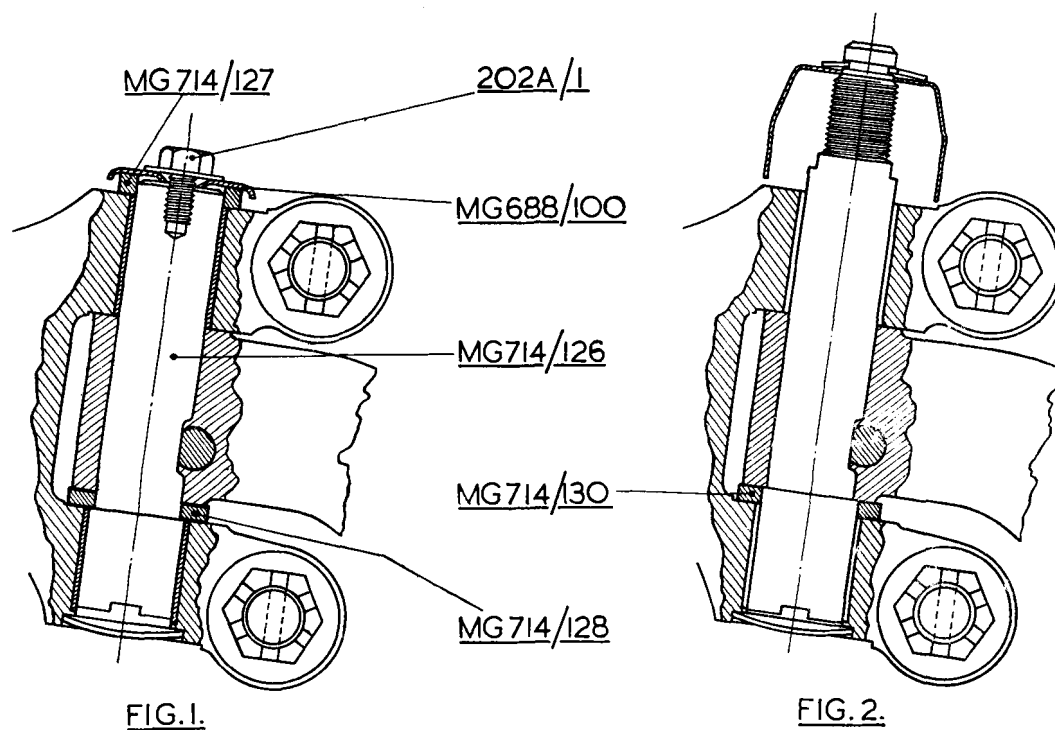
An alternative method (Fig. 2) enables a slightly modified thrust washer to be fitted to the original swivel pin. This modified washer, Part No. MG714/130, has a larger inside diameter to fit over the largest portion of the original type swivel pin. The ball race must be discarded, but the ball race dust cover and horse-shoe clip is refitted for appearance's sake.

It should be noted that only steering swivel pins of the latest type, Part No. MG714/126, bronze thrust washer Part No. MG714/128 or MG714/130, will be supplied, as the original type swivel pins and ball thrust races are discontinued.

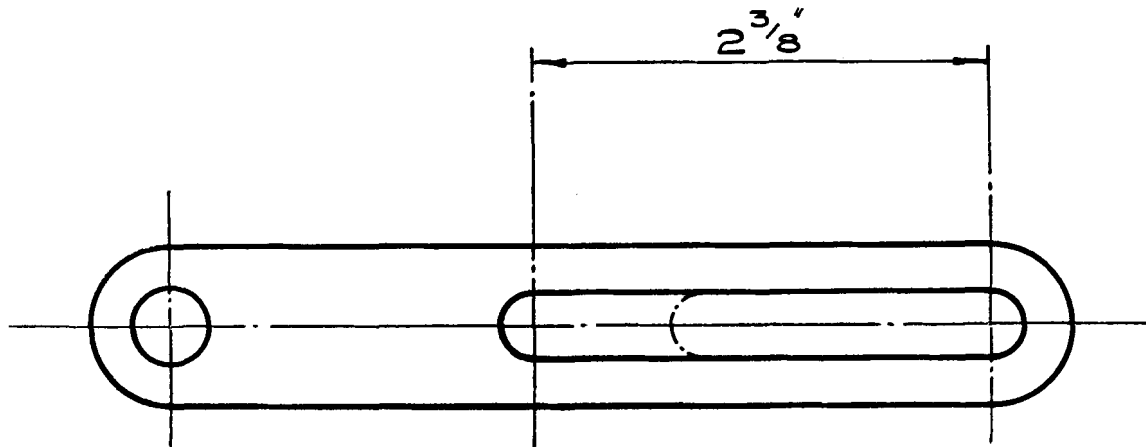
To provide a greater range of adjustment to the dynamo for adjusting the fan belt, a shorter belt is now being fitted. As the new type belt will be supplied for service replacement, it will be necessary to lengthen the slot in the dynamo support, otherwise the belt will be too tight when first fitted. The alteration necessary to the support is illustrated in the sketch below.

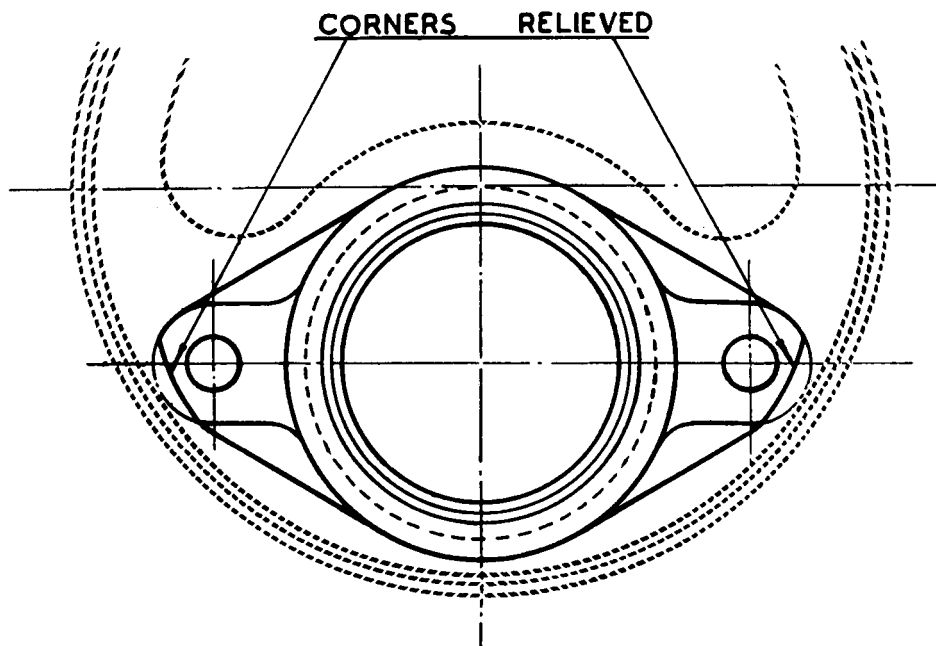
With the introduction of a slightly smaller diameter silencer on the Two-Litre model, it should be noted that, when fitting the new silencer as a replacement on the earlier cars, it will be necessary to relieve the corner of the exhaust pipe flange as illustrated.

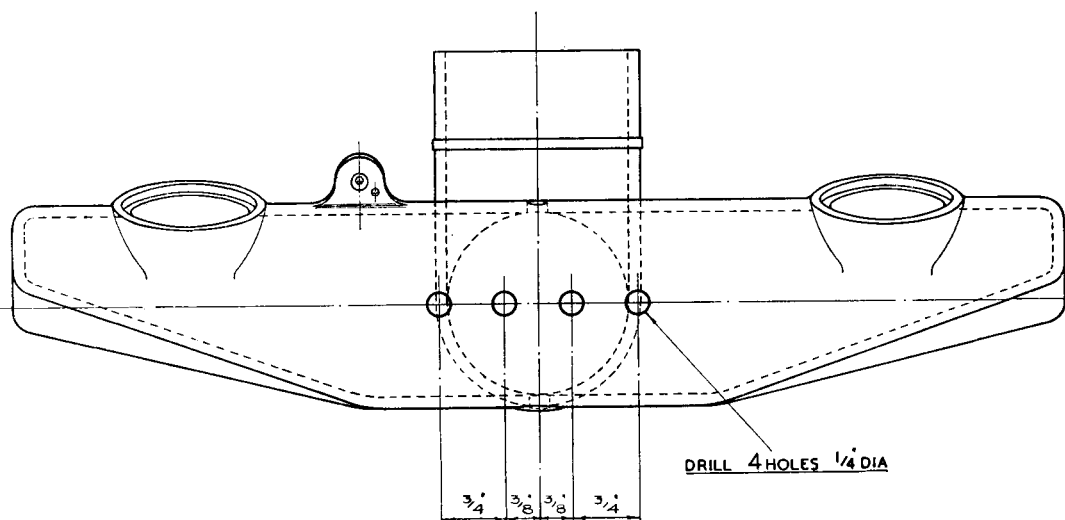
The sketch below illustrates the modification and Service Stations are asked to modify all stocks immediately and also to modify all cars coming in for service.

It is very necessary thoroughly to clean the manifold after drilling, and of course the air cleaner should be detached from the manifold to eliminate the possibility of aluminium drillings getting into the air cleaner filter.
