Service Information

Published by
The M.G. Car Company Ltd.
Abingdon-on-Thames

INDEX (Sheet 1)

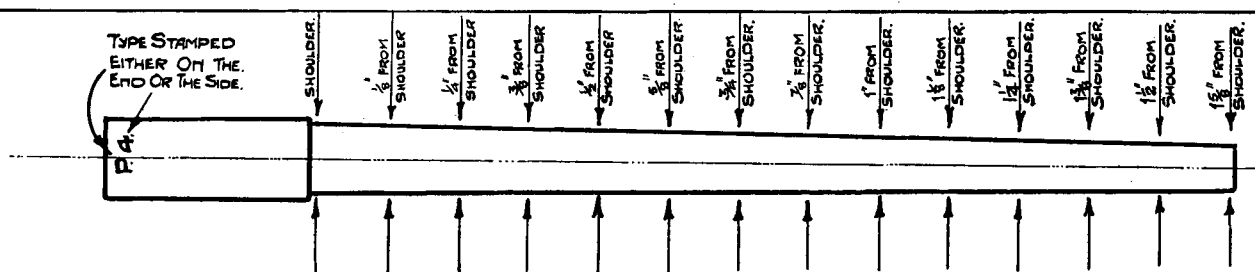
S.U. CARBURETTOR NEEDLES

TYPE OF NEEDLE.	USED FOR.	MEASUREMENTS IN THOUSANDTHS OF AN INCH.													
M.6.	M.G. MIDGET M. TYPE. WEAKER. 1929-32.	89	85	81.7	80.1	78.6	77	75.4	73.8	72.3	70.7	69.1	67.6		
M.5.	M.G. MIDGET M. TYPE.	89	85	81.7	79.2	77.6	76	74.5	72.9	71.2	69.6	68	66.6		
G.2.	STANDARD. 1929-32.	87.5	83.5	81	78.5	76.5	74.5	72.5	70.5	69	67.4	66	64.2		
Nº 2.	M.G. MIDGET M. TYPE RICHER 1929-32.	89	85	81.4	78.5	76.7	74.9	73.2	71.4	69.6	67.8	66	65	64

24.B.	M.G. M.K. I. AND MK. II (6 CYL) WEAKER. 1929-33.	88	84.5	81.5	79.5	77.5	75.5	73.5	71.5	69.5	67.5	65.5	63.5	61.5	
24.A.	M.G. M.K. I. AND MK. II (6 CYL) STANDARD. 1929-33.	88	84.5	81.5	78.5	76	73.8	71.6	69.8	68	66	64	62	60	
24	M.G. M.K. I. & MK. II (6 CYL) RICHER. 1929-33.	88	84.5	81.5	78.5	75.5	72.5	70.2	68.2	66.7	65	63.6	62.5	61	
M.6.	M.G. MAGNA. 'F' TYPE. WEAKER 1932-33.	89	85	81.7	80.1	78.6	77	75.4	73.8	72.3	70.7	69.1	67.6		
M.5.	M.G. MAGNA. 'F' TYPE. STANDARD. 1932-33.	89	85	81.7	79.2	77.6	76	74.5	72.9	71.2	69.6	68	66.6		
Nº 1.	M.G. MAGNA. 'F' TYPE. RICHER. 1932-33.	89	85	81.4	78.5	77	75.5	74	72.5	71	69.5	68	67	66	
M.6.	M.G. MIDGET 'D' TYPE. WEAKER. 1932.	89	85	81.7	80.1	78.6	77	75.4	73.8	72.3	70.7	69.1	67.6		
M.5.	M.G. MIDGET 'D' TYPE.	89	85	81.7	79.2	77.6	76	74.5	72.9	71.2	69.6	68	66.6		
G.2.	STANDARD. 1932.	87.5	83.5	81	78.5	76.5	74.5	72.5	70.5	69	67.4	66	64.2		
Nº 2.	M.G. MIDGET 'D' TYPE. RICHER 1932.	89	85	81.4	78.5	76.7	74.9	73.2	71.4	69.6	67.8	66	65	64

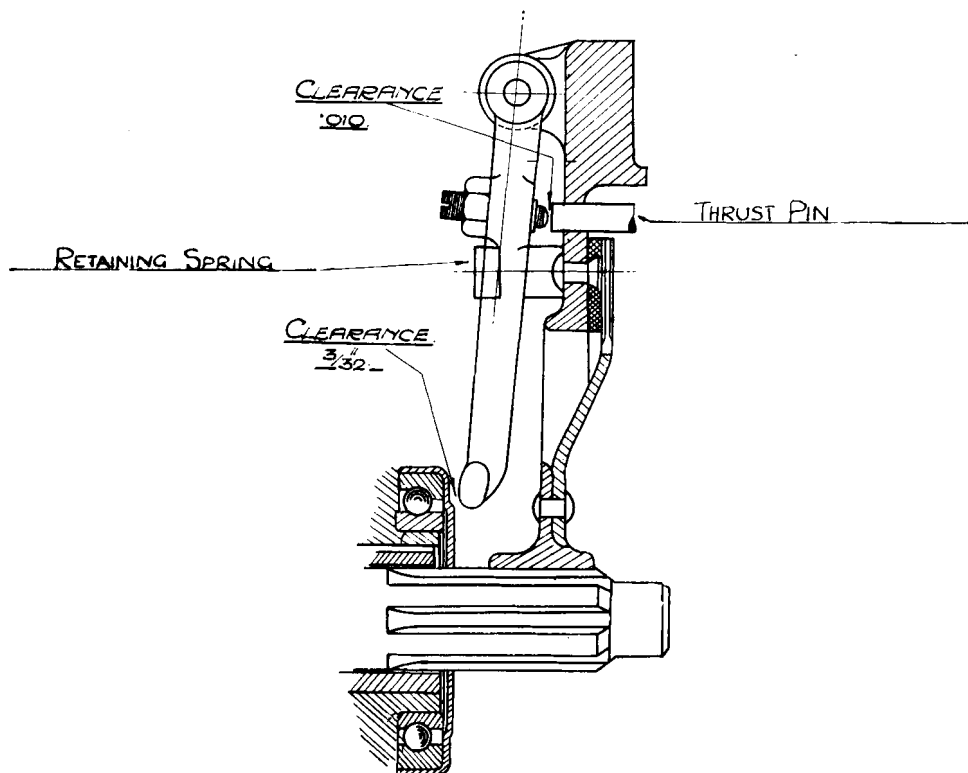
It has been thought advisable to issue information regarding clutch adjustment as cases have come to our notice where incorrect adjustment has caused excessive wear to the clutch fingers. The first adjustment is between the clutch fingers and the clutch thrust race. The clearance should be measured by a gauge $\frac{3}{32}$ in. thick (see drawing), care being taken to get the same clearance for each finger.

The second adjustment, which is equally important, concerns the amount of movement the clutch fingers have between the retaining springs and clutch operating pins. The duty of the retaining springs is to prevent the fingers fouling the thrust race. These springs, therefore, should be set carefully to allow a .010 in. gauge to be inserted between the clutch adjusting screw and the clutch thrust pin, as indicated on the drawing.

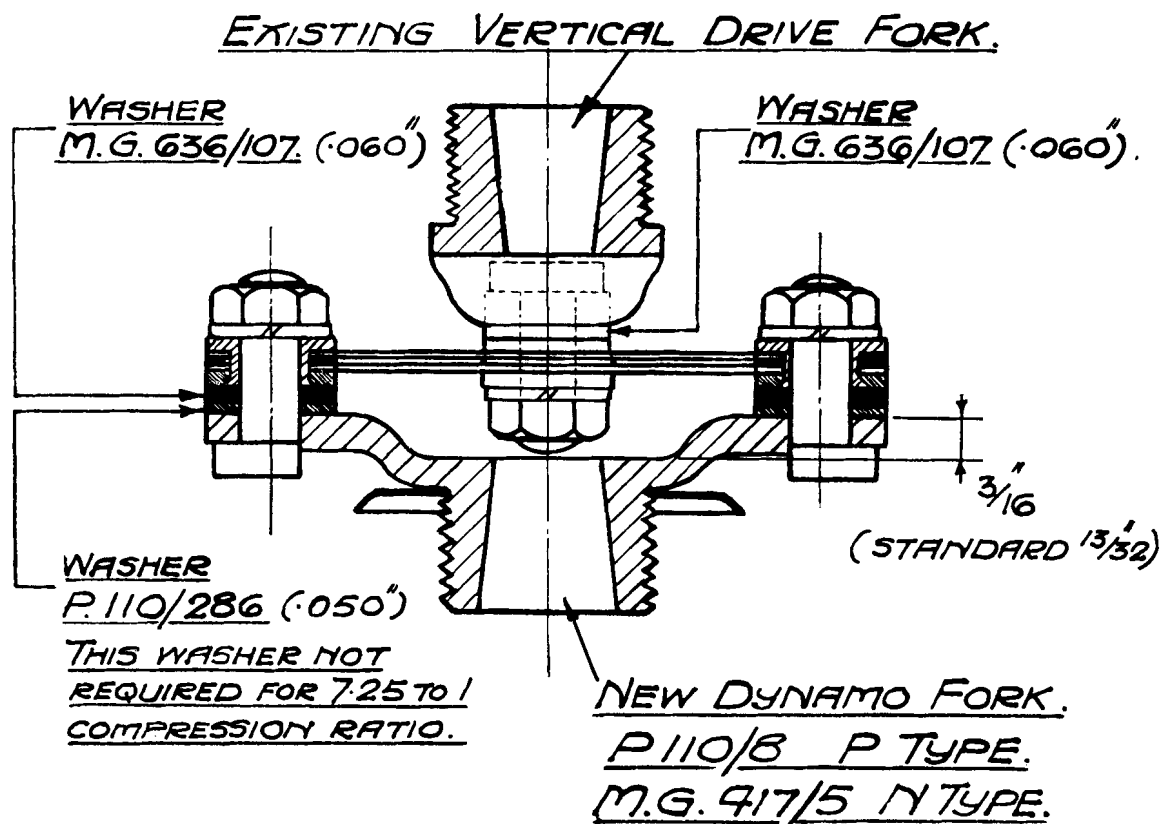
**VERTICAL DRIVE COUPLING ARRANGEMENT.****6.7 TO 1 COMPRESSION RATIO.**

To raise the compression ratio to 6.7 to 1 the cylinder head face must be machined to give an overall depth of $3\frac{1}{8}$ in. instead of the standard dimension of $3\frac{1}{4}$ in. The standard copper and asbestos gasket is retained, and this is always advisable and is to be preferred to the employment of a very thin steel gasket or no gasket at all, as with both the latter the making of a sound joint is always very difficult unless the operation is carried out by a highly skilled man. It will be appreciated that as a result of raising the compression ratio the dimension between the dynamo and cylinder head is reduced by a similar amount, necessitating the use of a more shallow dynamo drive fork. The sketch indicates the forks required together with the necessary packing washers.

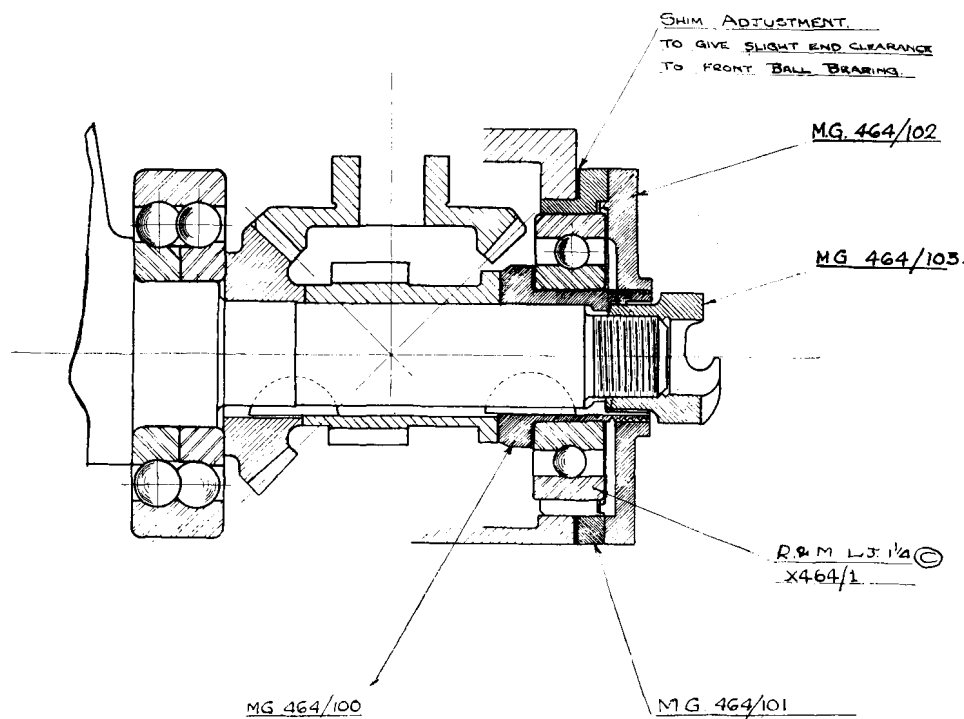
This modification is not difficult to fit, but the following remarks will be of assistance :—

1. Slacken the engine fixings to enable the front end to be dropped sufficiently to allow the engine nosepiece and crankshaft thrust washers to be removed, taking care to support the front end of the engine.
2. The crankshaft must be accurately tested for longitudinal movement and this must not exceed .008 in. If the movement is in excess of .008 in. a new main ball race should be fitted, as the secondary race must not be allowed to take any thrust load.

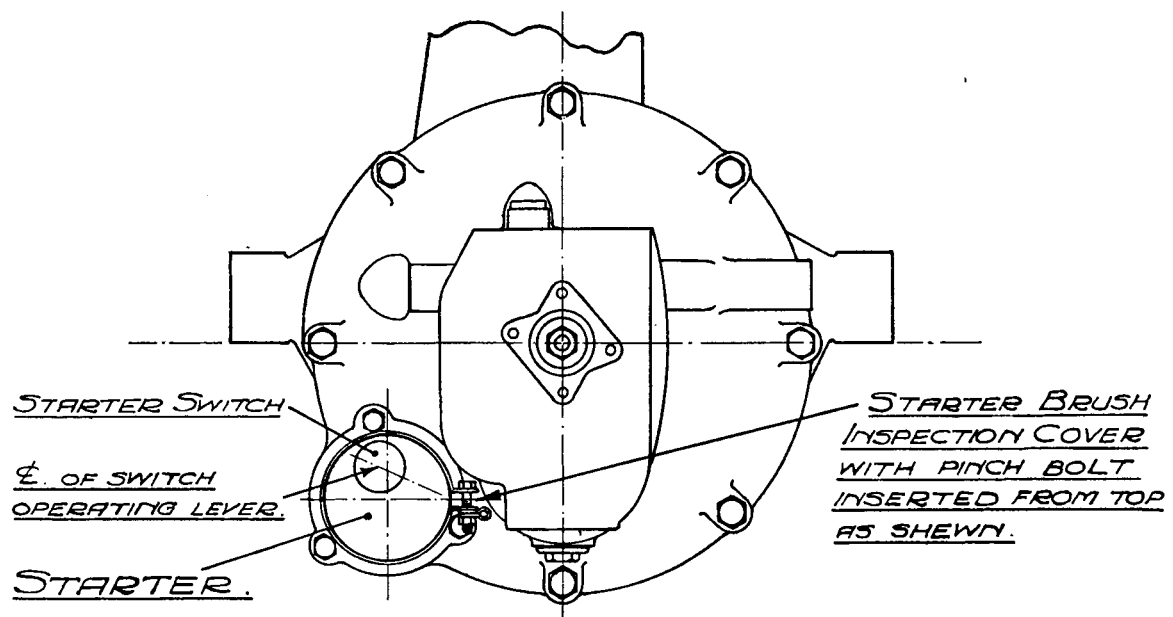
REAR VIEW OF TWO-LITRE ENGINE.

The necessary adjustment is governed by the outer casing clip, secured to the starter brush inspection cover, and the length of inner cable, which is lengthened or shortened by the pinch bolt screwed into the starter switch operating lever.

The most suitable position for the clip securing the cable outer casing is illustrated in the sketch below.

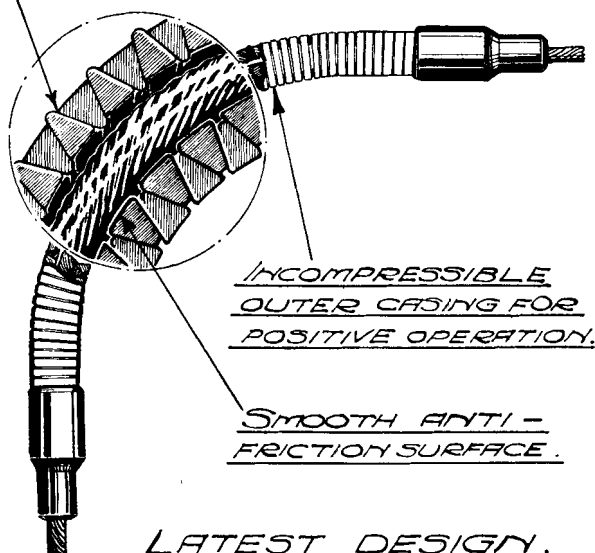
NO GAP HERE.
GREASE RETAINED.
WATER EXCLUDED.

It is a matter of considerable importance to ensure that the new cables are fitted in pairs per axle, as one of the new type fitted in conjunction with one of the old type will inevitably result in uneven braking.

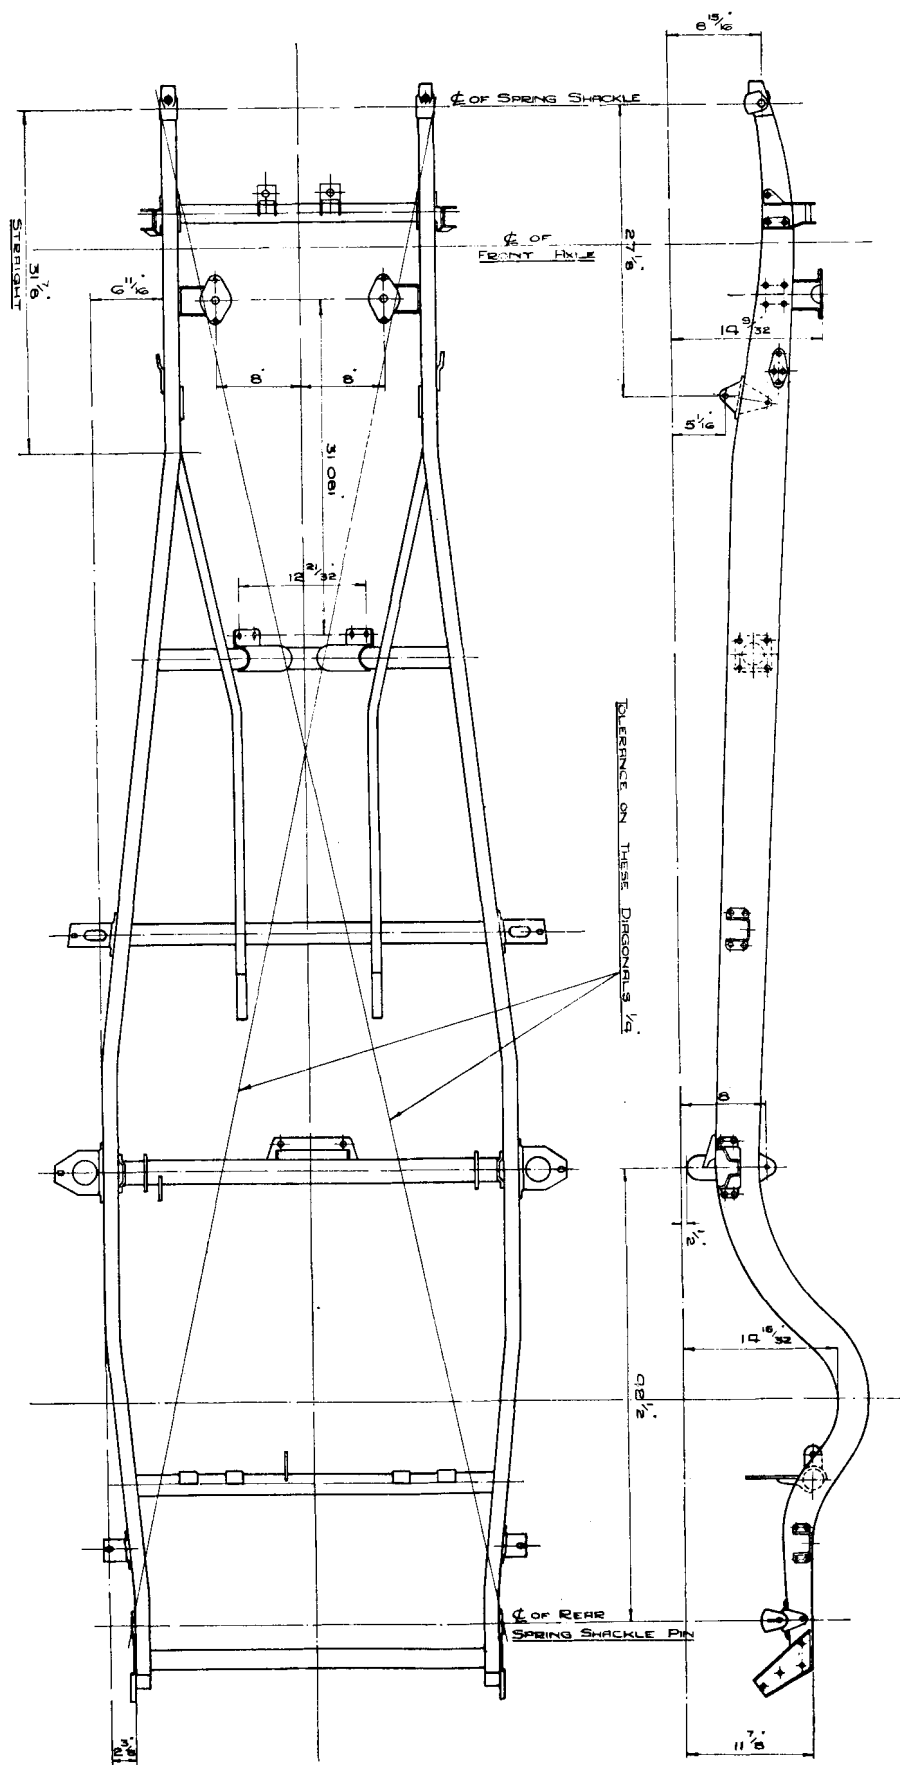
CHASSIS DIMENSIONAL DRAWING

It has been pointed out that the Chassis Dimensional Diagram at present appearing in the Instruction Manual for the 1½-Litre VA. Type is inaccurate. The discrepancies have now been rectified and the correct diagram is given below.

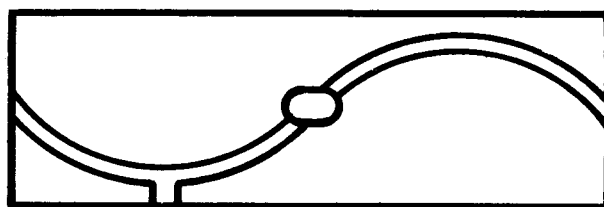
BUSH TO BE FITTED WITH GROOVE
TOWARDS AXLE BEAM
(View of Bush before being rolled)

The king pin bushes for the above models have been modified to give more efficient lubrication of the king pins. The oil grooves are designed to lubricate the thrust surfaces also, and it must be noted, therefore, that there is a correct method of fitting the bushes to the stub axle. The same remark applies to both top and bottom bushes.
