J2 TECHNICAL ARTICLE

Number 172

WINDSCREEN/ COWL RUST REPAIR

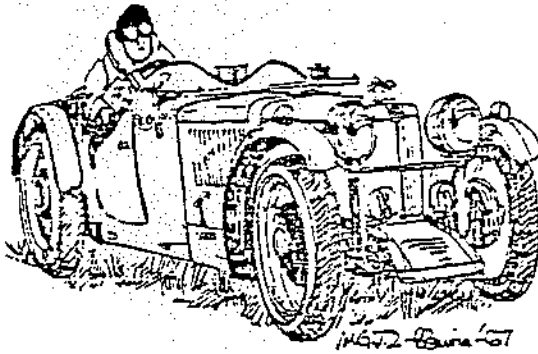
On the earlier M.G.'s there is likely to be rust problems under the windscreen mounting brackets because of a poor rubber gasket often did not seal the space between the bracket and the body and water can get behind the bracket.

The rust starts at the bolt holes and then spread weakening the mount but still hidden by the bracket. You may be unaware of it until damage has been done.

The best method of repair is to butt-weld a patch plate to the surrounding metal. The second best method is to lap-weld the similar pieces under the old metal and fill the exterior with lead or bondo (fiberglass).

Which ever repair method that you use, you must first make a template showing the proper locations of the bolt holes. This should be done from specific reference points on the body to be able to align the template afterwards.
