J2 TECHNICAL ARTICLES

From Octagon Heaven

Number 41

MORE ON THE INTERIOR - CONTINUED FROM ARTICLE NO. 10

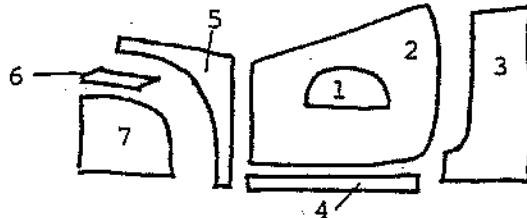
1. Door panels on back of door steel-with M.G. Motif
2. Door panels with formed pockets
3. Kick panels under scuttle sides
4. Panels under doors (down to floor)
5. Wheel arch panels

6. Top rear wheel arch panels (hood frame attached onto)
7. Vertical wheel arch panels
8. Covering inside of tub over wheel arch
9. Covering inside of tub back panel
