J2 TECHNICAL ARTICLE

Number 164

CLUTCH ADJUSTMENT AND STOP

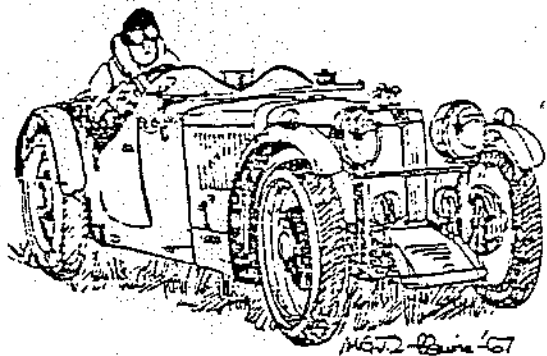
I have however found some indication that there was a stop adjustment. First, the clutch pedal has a boss on the inside (left) of the pedal arm. Secondly I happened to find a picture with illustrations in a January 1932 service information sheet from the M.G. Car Company. This was published before J2 production but is about the J2 gear box.

On the right side of the illustration is a "Clutch pedal travel adjustment."

I can not find any indication as to how it should be set. Maybe it is to keep the pedal from hitting the bulk head, excluder plate, or bell housing?

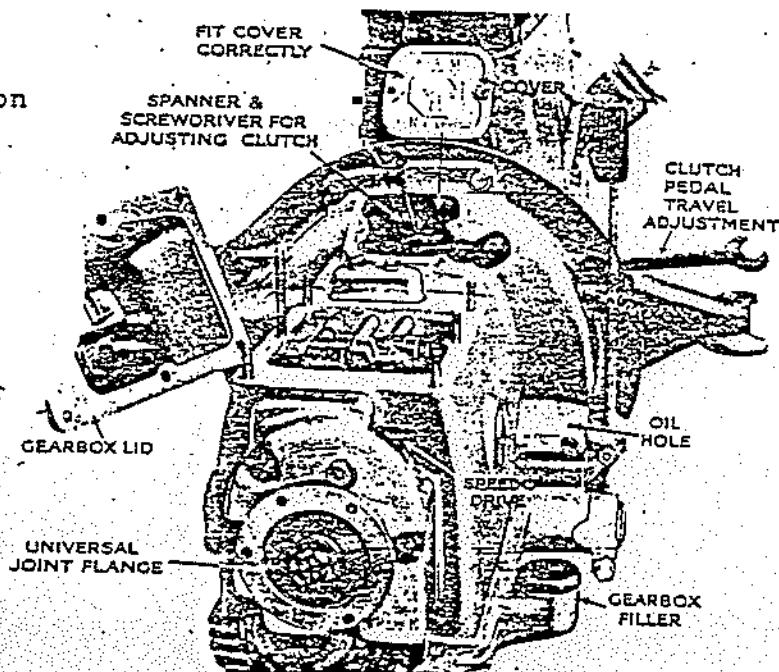
This adjustment is one of the bolts that hold the bell housing onto the engine. It must be a longer bolt with a lock nut to be able to still do its first function of holding the bell housing to the engine.
