## J2 TECHNICAL ARTICLE

Number 52

### SERVICE INFORMATION SHEET NO. 9D - BRAKING SYSTEM

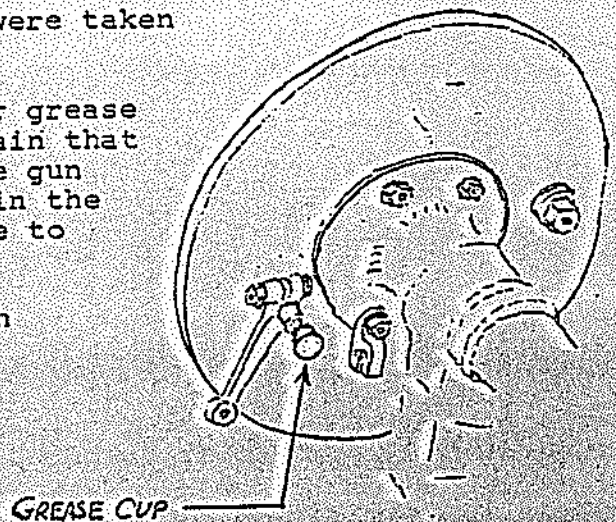
The pictures in the owners manual were taken prior to this engineering change.

This modification should be on both front and rear brakes.

It has therefore been decided that these bushings will be fitted with Stauffer Greasers on all models to be produced for future delivery.

These greasers are of the cup type, and should be refilled every 500 miles, lubrication being regulated by periodical adjustment of the screwed cap with which they are fitted.
