MMM Clutch Models C/J4/L/K MMM Clutch Models P/K/N

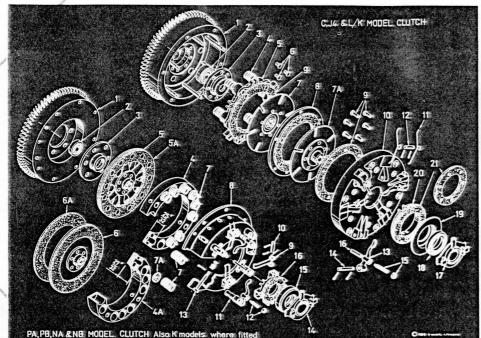
Qty. Pic. Part **Description and Remarks** 565 Flywheel 622 Clutch spigot bearing with seal. 648 Clutch spigot bearing housing. 649 Clutch springs (set of 6). 638 Alloy pressure plate. Hardened clutch thrust buttons. Clutch driven plate (front). 639 650 Clutch centre floating plate (lined). 651 Clutch driven plate (rear). 640 Clutch lining set with rivets. Clutch cover plate (alloy). Clutch toggle springs. 653 Toggle spring fulcrum pin. 653A 654* Clutch operating finger. 655* Clutch finger pivot pin. 656 Clutch finger adjusting screw/nut. Hardened clutch operating pins. 635 Clutch thrust bearing carrier. 636 Clutch thrust bearing (very limited). Clutch thrust bearing (saucer) cover. 658* 659* Clutch thrust plate (lined). 659A Your clutch thrust plate - relined.

Pic.	Part	Description and Remarks	Ωty.
1	566*	Flywheel.	1
2	622	Clutch spigot bearing with seal.	110
3	660*	Clutch spigot bearing housing.	1
41	661*	Clutch pressure plate. (Thin) (Ceased engine No.2001AP).	1
4A1	662*	Clutch pressure plate (Thick) (Comm.Eng. No.2002AP).	1
5 66	663*	Clutch driven plate (thick) (ceased engine No.2001AP).	1
		(Linings are not available seperately for this type of plate).	
5A	664	Your clutch driven plate. Relined and recorked.	
61	665*	Clutch driven plate (thin) (Comm. eng.No.2002AP).	1
6 A	666	Lining set for clutch plate 665 (simply bond on).	Set
7	667	Clutch springs (set of 12).	Set
7 A	668	Insulating pads for clutch springs (Engine No.2002AP — end).	12
8	669*	Clutch cover plate; complete.	*
9	670	Clutch toggle springs (mousetrap type).	4 *
10	670A	Toggle spring fulcrum pin.	4
11	671*	Clutch operating finger and pin.	4
12	672*	Clutch finger adjusting screw/nut.	4
13	673*	Clutch operating finger mounting bolt assembly.	4

14	635*	Clutch thrust bearing carrier.	1
15	674	Clutch thrust bearing and cover combined.	100
16	675	Clutch thrust pressure pad — lined	1

Difficulty in obtaining a clutch or correct clutch adjustment is often experienced when assembling the P/N clutch. This is usually due to an incorrect combination of an early, thicker, clutch driven plate (Part No. 663), (identified by cork inserts in the lining), matched to a late, thicker clutch pressure plate (Part No. 662) or vice versa.

It is essential that the thinner clutch pressure plate of $25/32^{\prime\prime}$ thickness is matched to the thicker cork inserted clutch driven plate; and the thicker pressure plate (Part No. 662) of $27/32^{\prime\prime}$ is matched to the thinner clutch driven plate (Part No. 665).
